**CARMAN WATERSHED RESTORATION PROJECT PHASE 2  
POST-PROJECT and ADAPTIVE MANAGEMENT  
MONITORING REPORT**

**SITES 1, 2, 4, AND 8**

**(California Department of Fish and Wildlife Watershed Restoration  
Grant Program Agreement #P1796015)**

**March 2020**

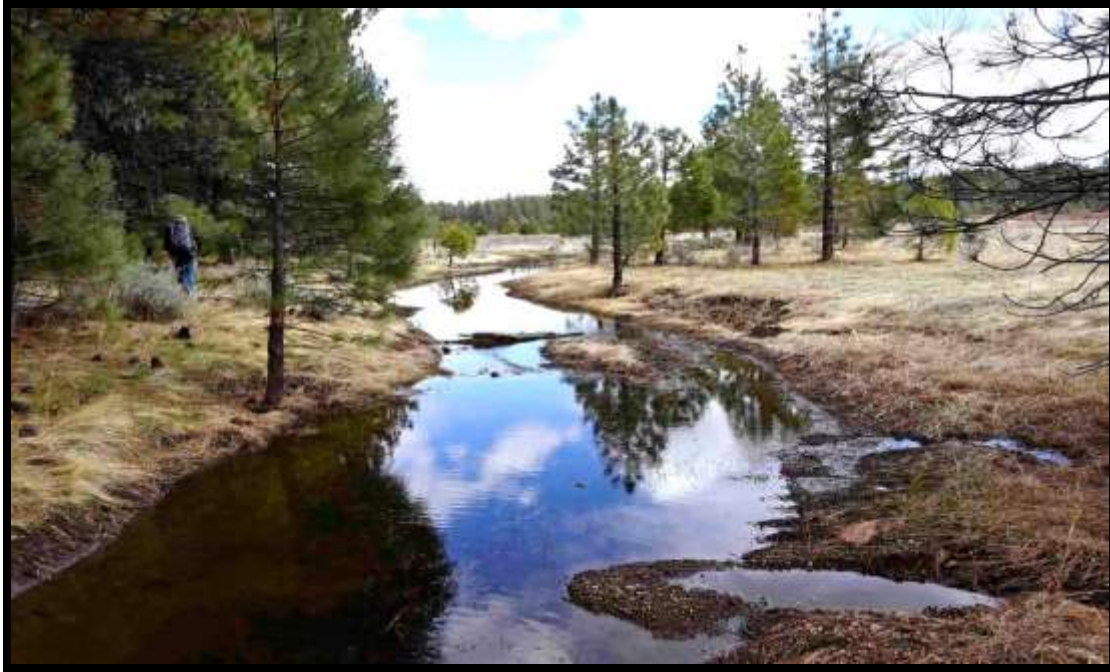
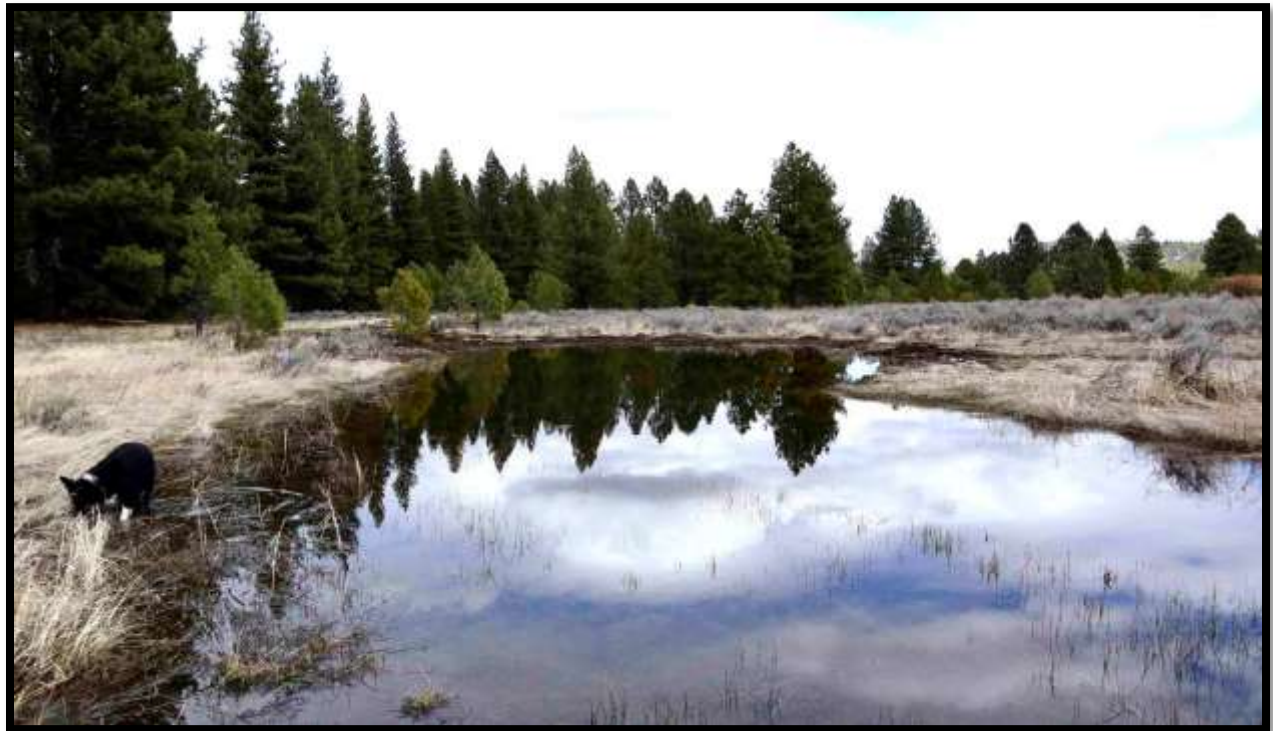
**Carman Creek Ponding and Increased Surface Water Levels  
Due to Downstream Fill Feature March 2020 (View E)**

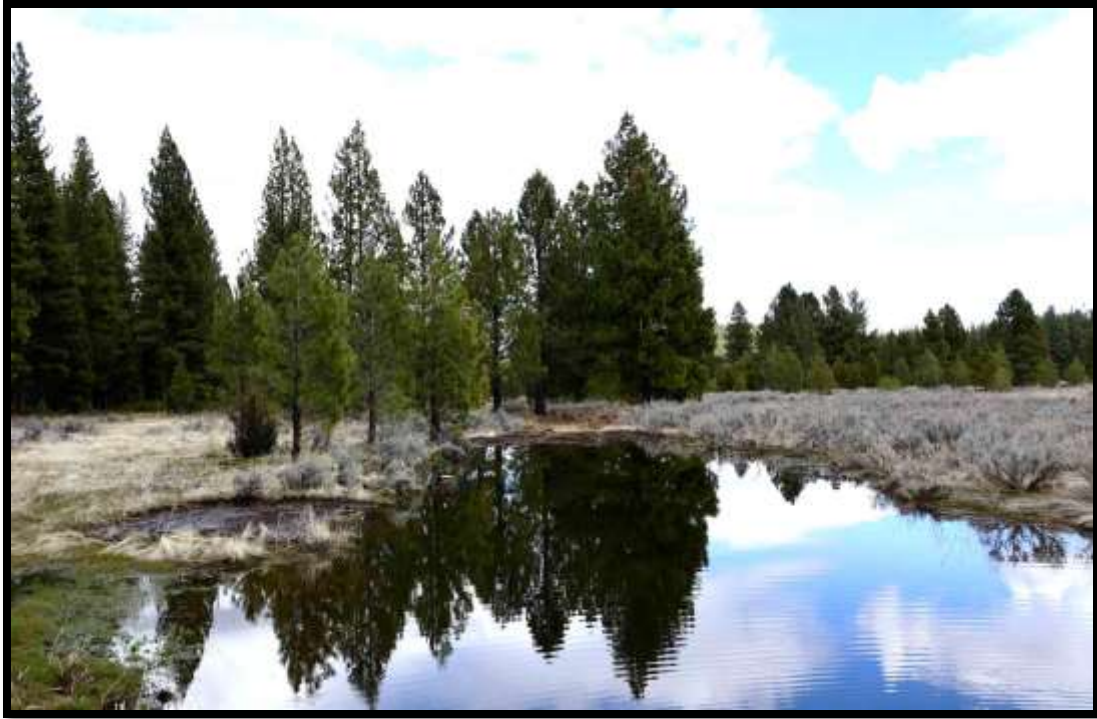
**Carman Creek Ponding and Increased Surface Water Levels  
Just Above Downstream Fill Features March 2020 (View SW)**

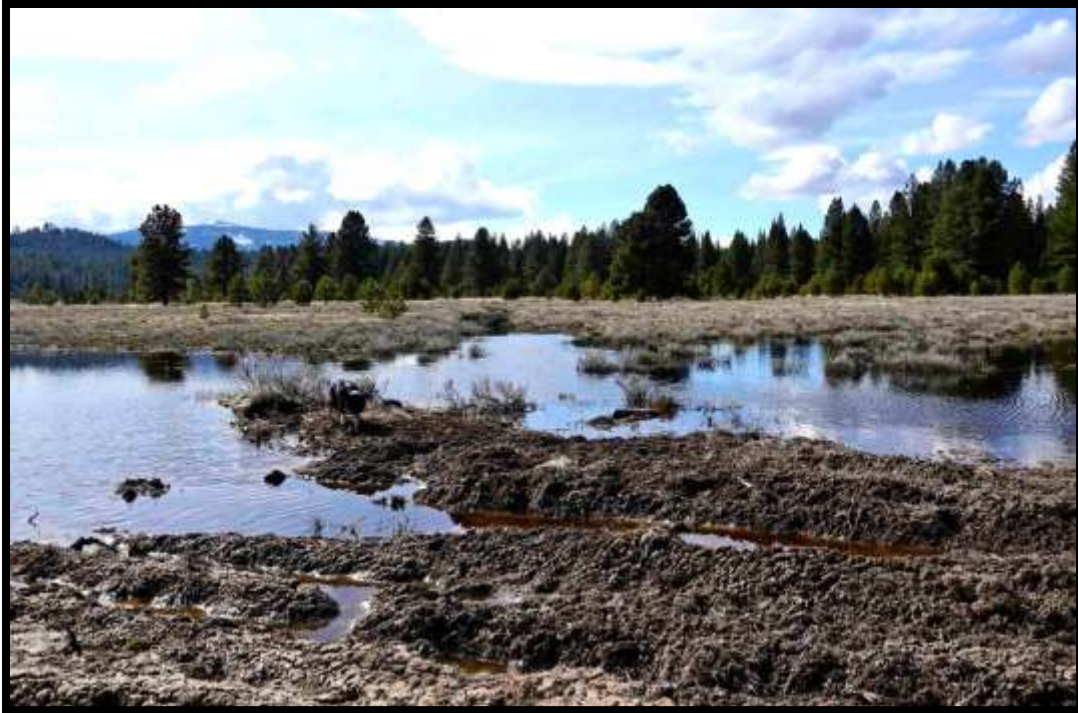
**Southeast Channel Inflow Ponding Just North of Photo Monitoring Station #1  
and South Boundary Fence March 2020 (View N)**

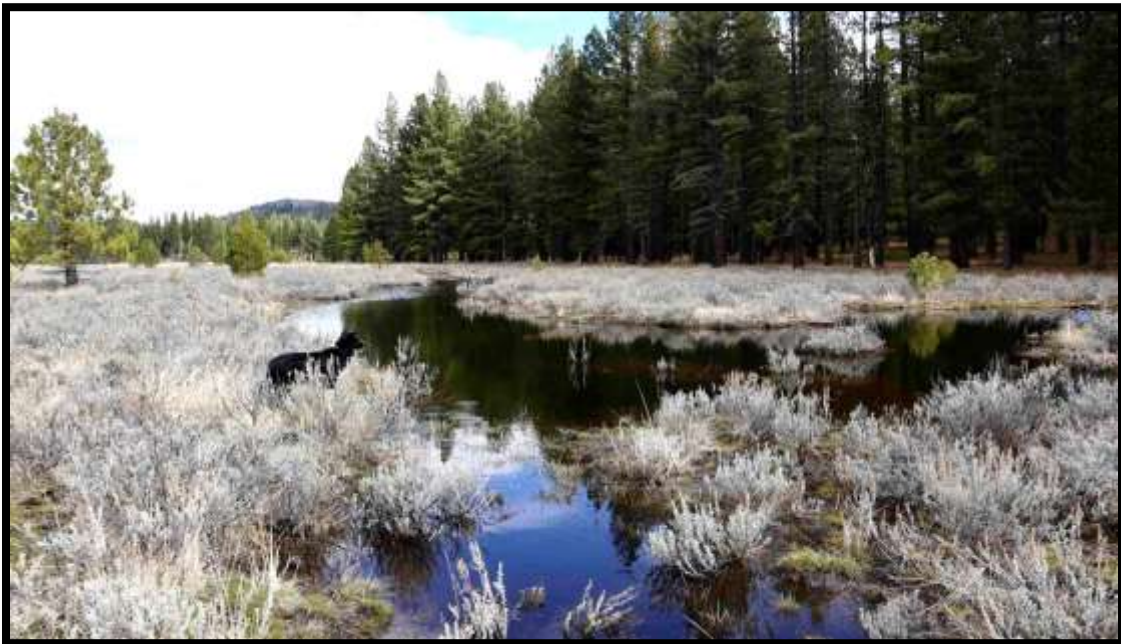
**Southeast Channel Inflow North of South Boundary Fence  
March 2020 (View NE)**

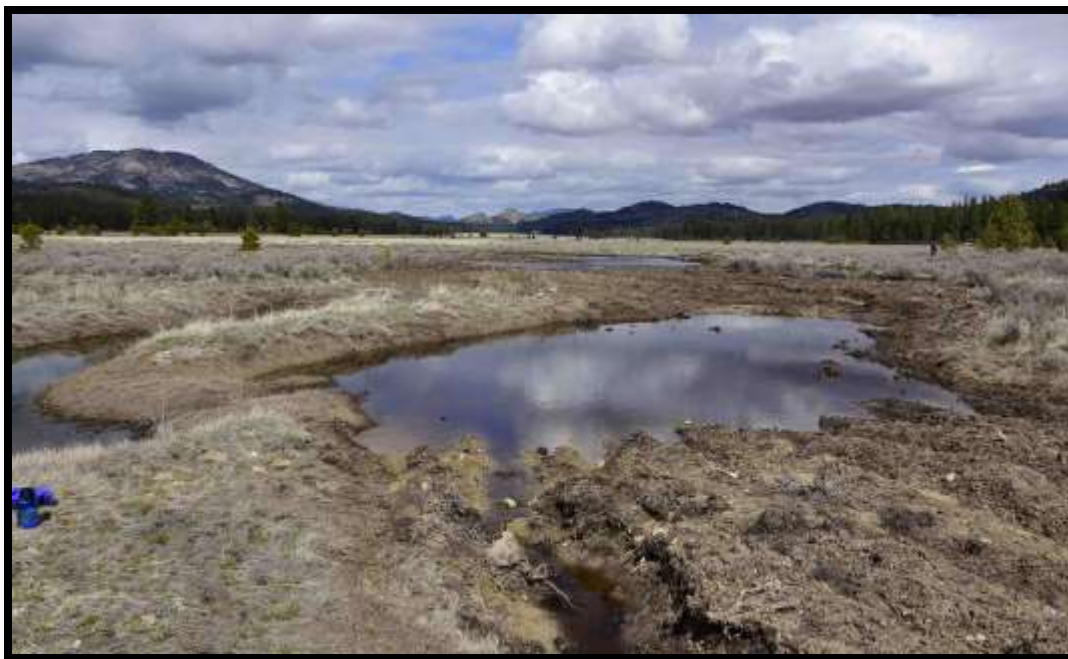
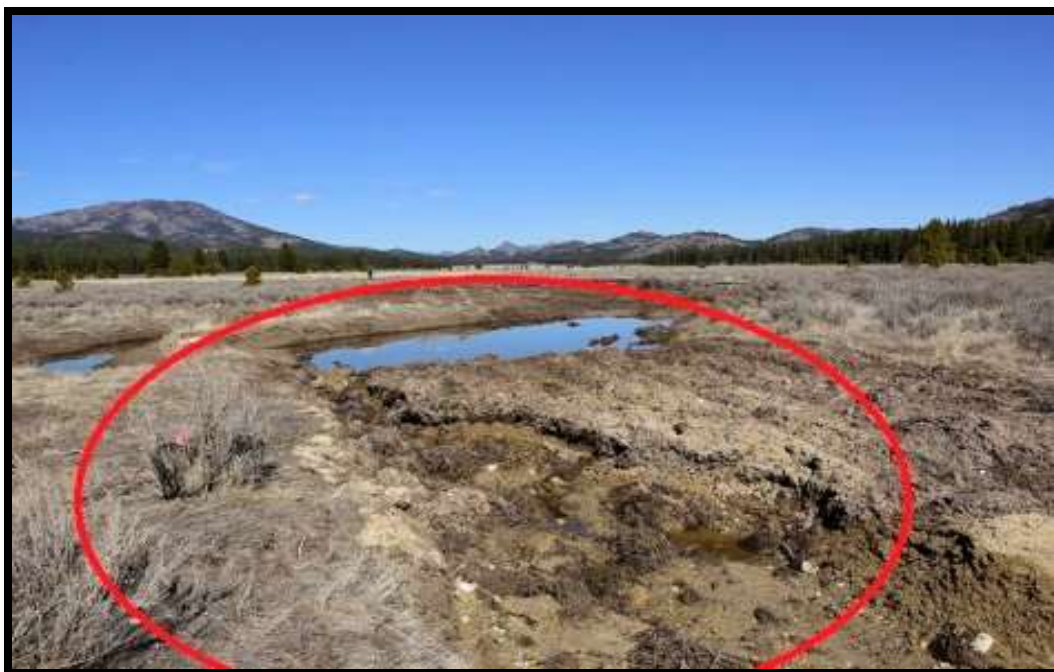
Bottom fill areas of Site #1 Folchi Meadows and Carman Creek are exhibiting some minor settling and erosion. Adaptive management measures to stabilize these areas are included in this report and will be implemented by the TNF during 2020 to ensure proper long-term function and restoration success.

**Folchi Meadows**  
**Photo Monitoring Station #1 Impounded Flow From East Channel**  
**and Minor Erosion of South Boundary Fence Filled Feature March 2020 (View N)**

*Two areas within the Folchi Meadows project areas shown in this monitoring report are currently in need of minor stabilization measures. These areas include: 1) Folchi Meadows bottom fill feature at south fence and 2) Carman Creek bottom fill area. Both of these fill features are exhibiting some minor settling and erosion. Adaptive management measures to stabilize these features should be implemented as soon as weather/road access permits to ensure proper long-term hydrologic function and restoration success.*

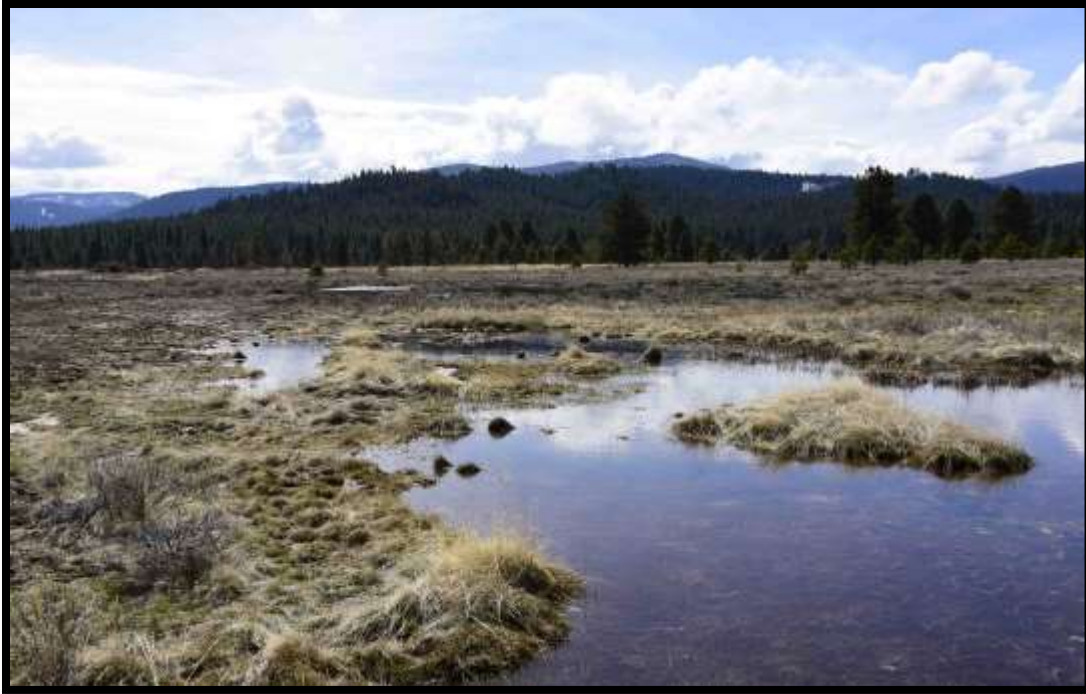
**Folchi Meadows South and Mid-Central Overland Flow Originating from West Peat Bog Spring March 2020 (View SW)**

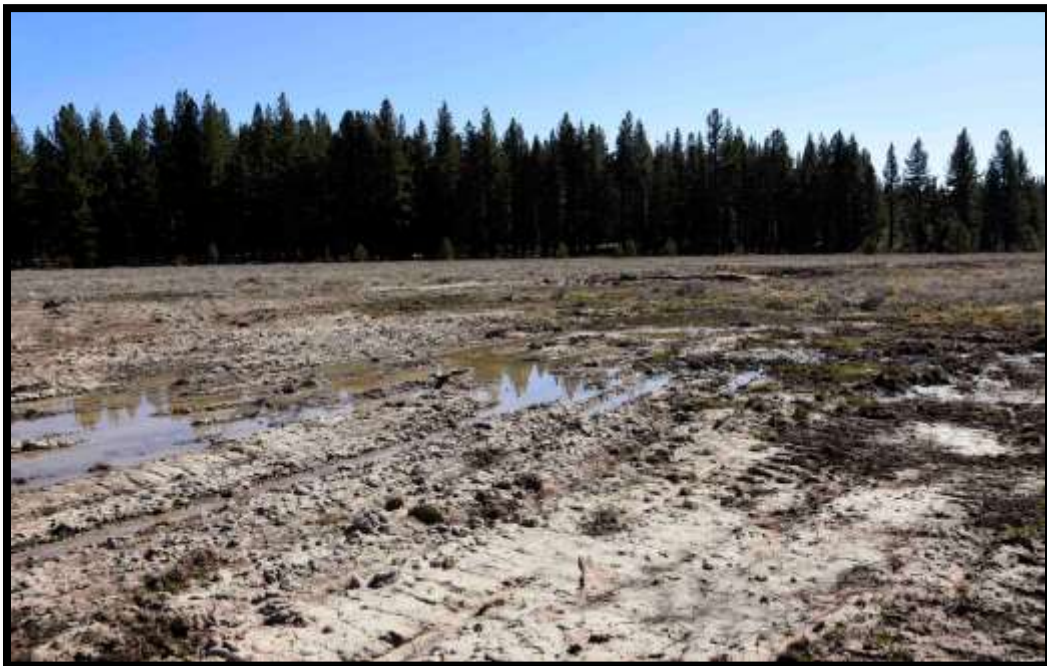
**Photo Monitoring Station #2 Showing Overland Flow Originating From Existing Peat Bog Spring Across Filled Gully (View S)**

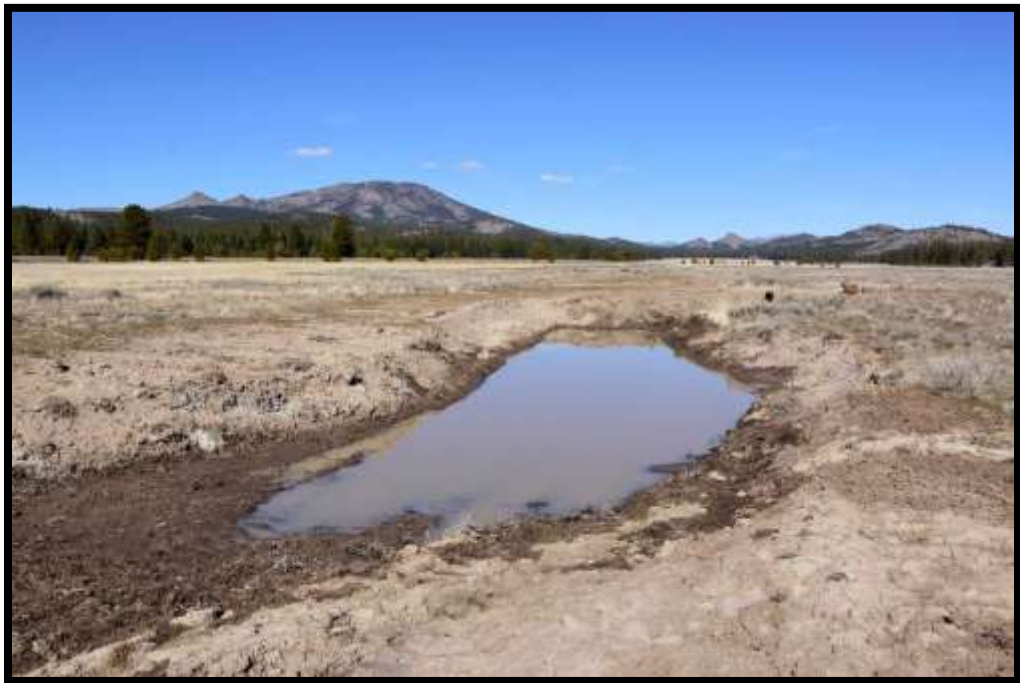
**Photo Monitoring Station #2 Water Feature Near Groundwater Well #1  
March 2020 (View NW)**

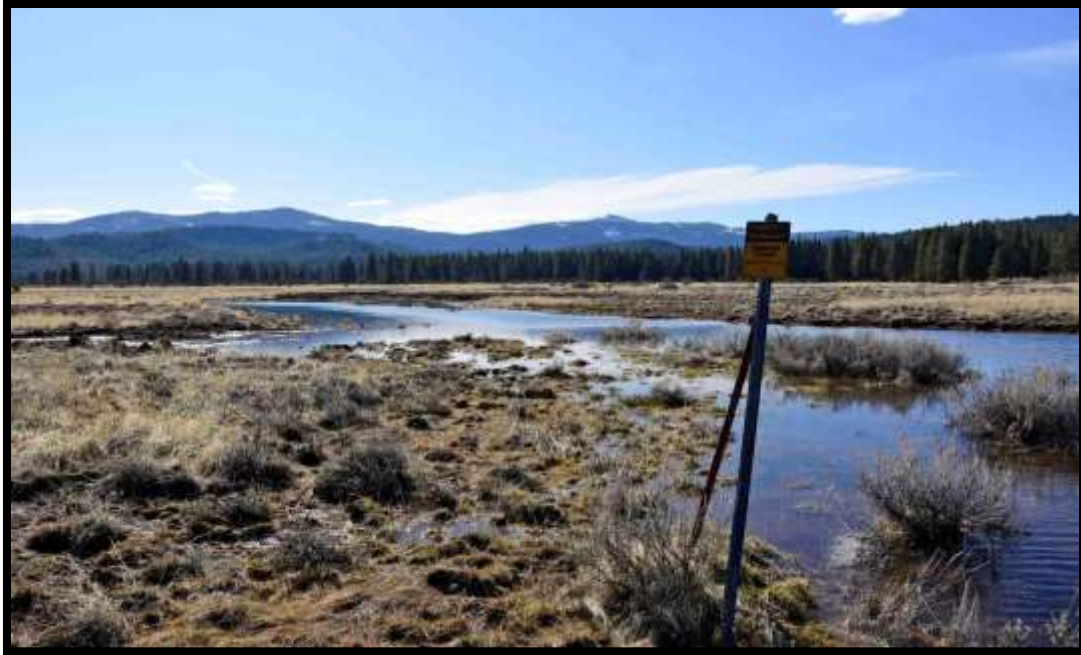
**Folchi Meadows North Forest Service Boundary Restoration Area Inflow  
Ponding and Conveyance to Re-Connected Remnant Floodplain Channels  
February 2020 (View SW)**

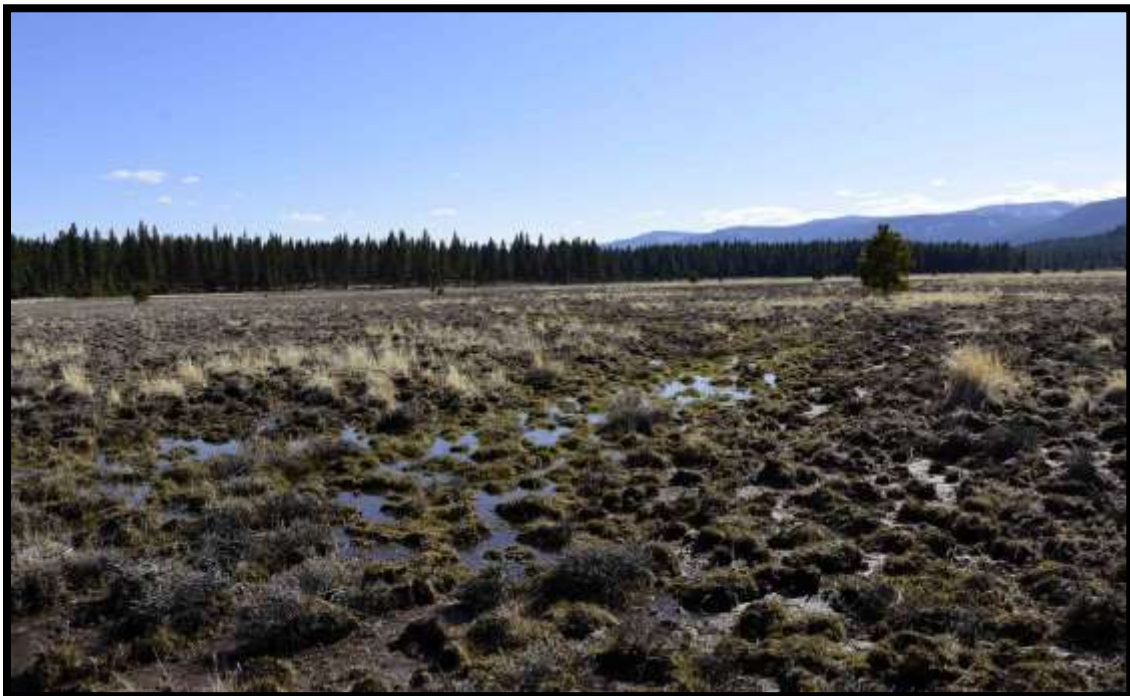
**Hydrologic Conveyance Within Re-Connected Remnant Floodplain Channels (View S)**

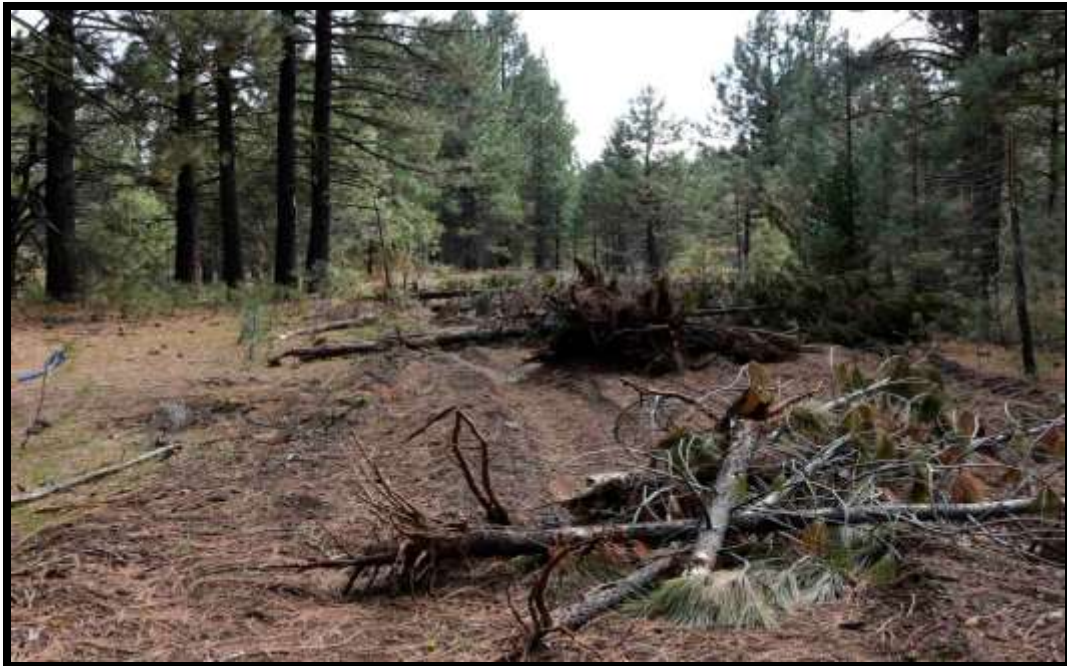
**Carman Creek Access Road Rehabilitation Through Archeological Site  
March 2020 (View S)**

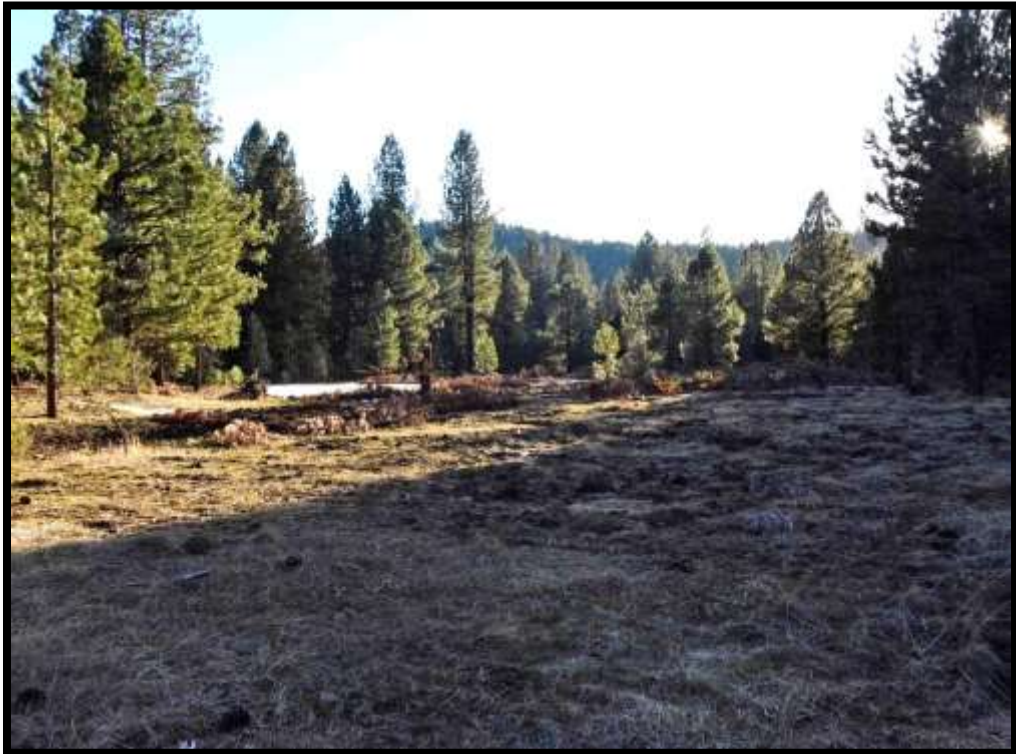
**PM #1 Upper Meadow at North Project Area Boundary**

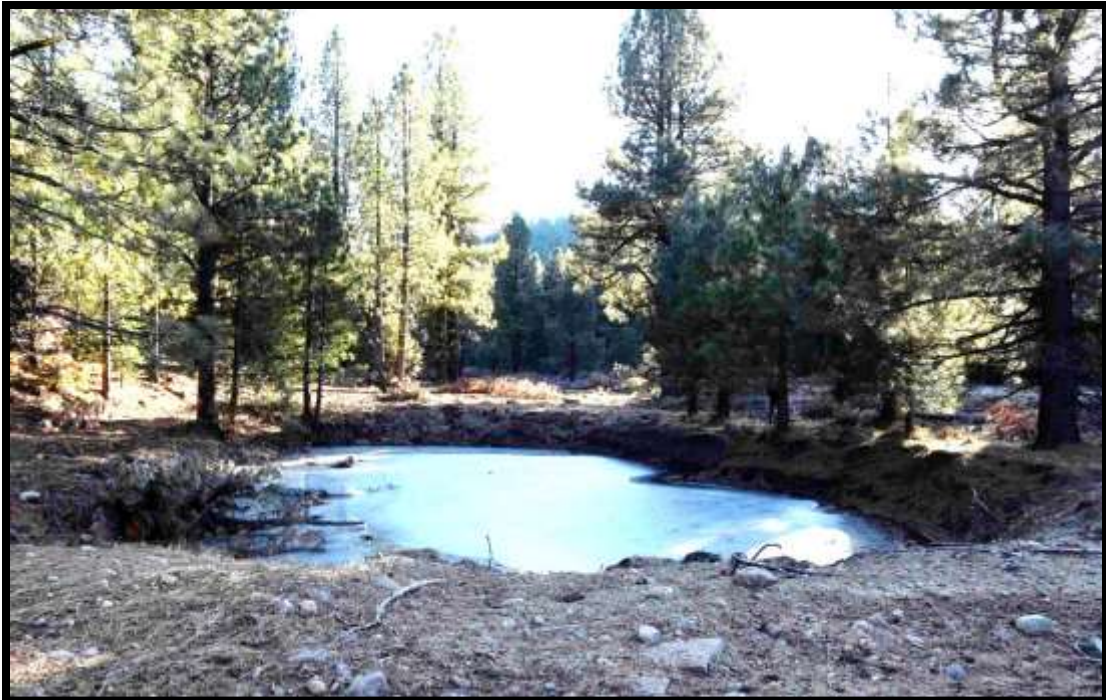
**Upper Retained Water Feature Post-Project Groundwater Level February 2020 (View S)**

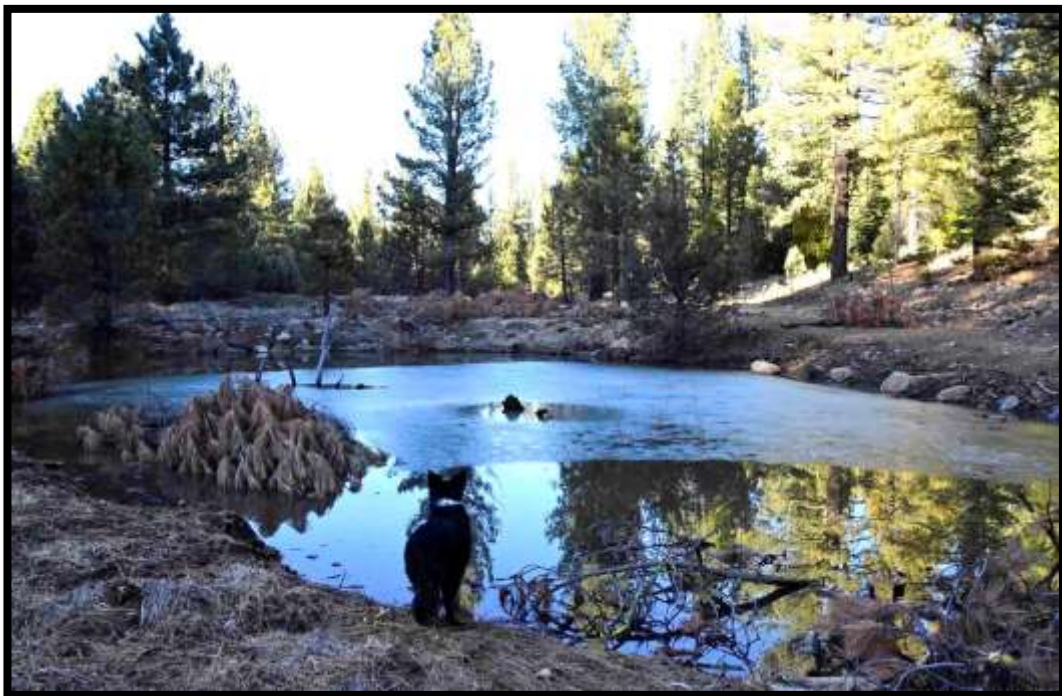
**Lower Retained Water Feature Post-Project Groundwater Level February 2020 (View N)**

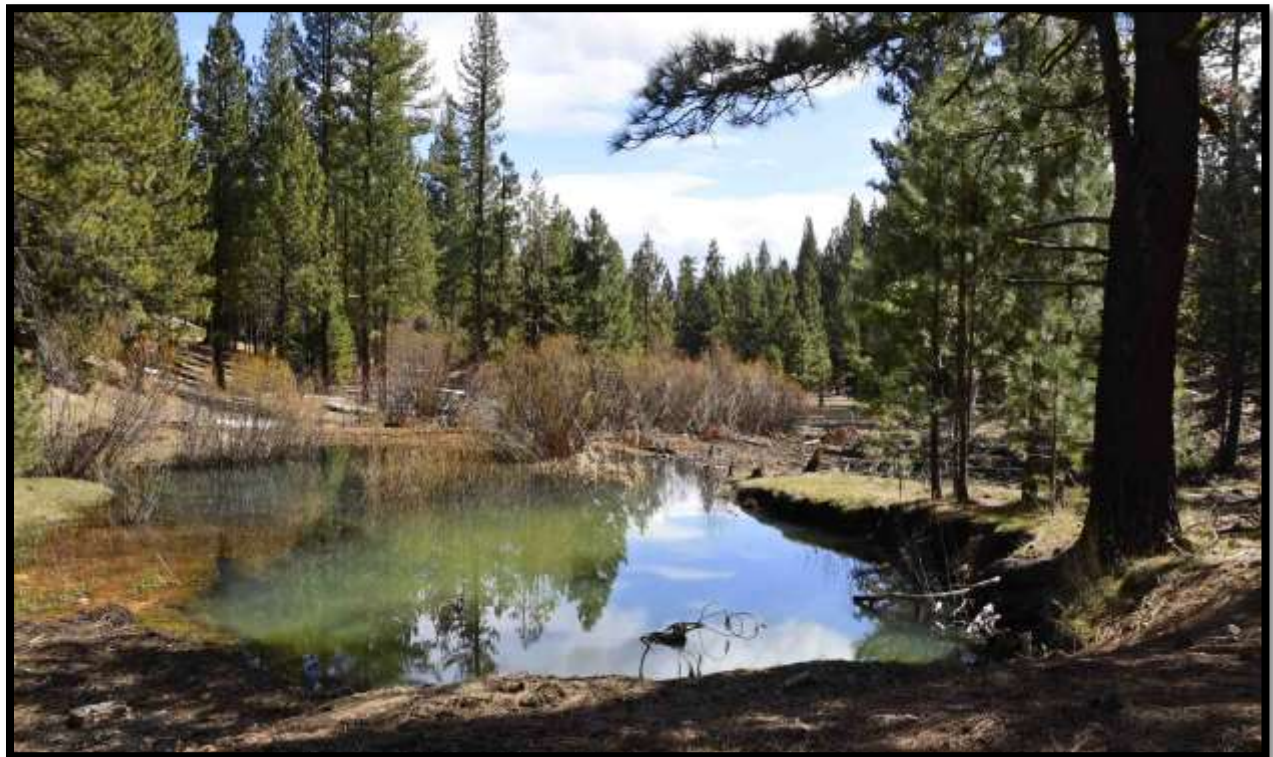
**Southeast Retained Spring Pond March 2020 (View NE)**

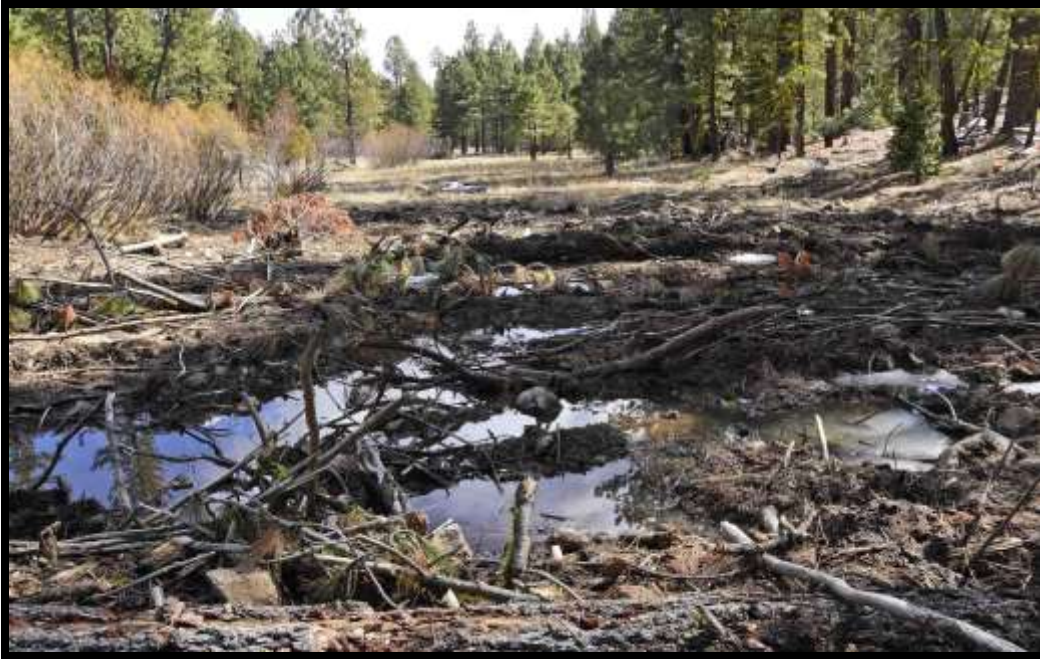
**Southeast Log Grade Control Structure Slowing Pond Runoff (Bottom)(View E)**

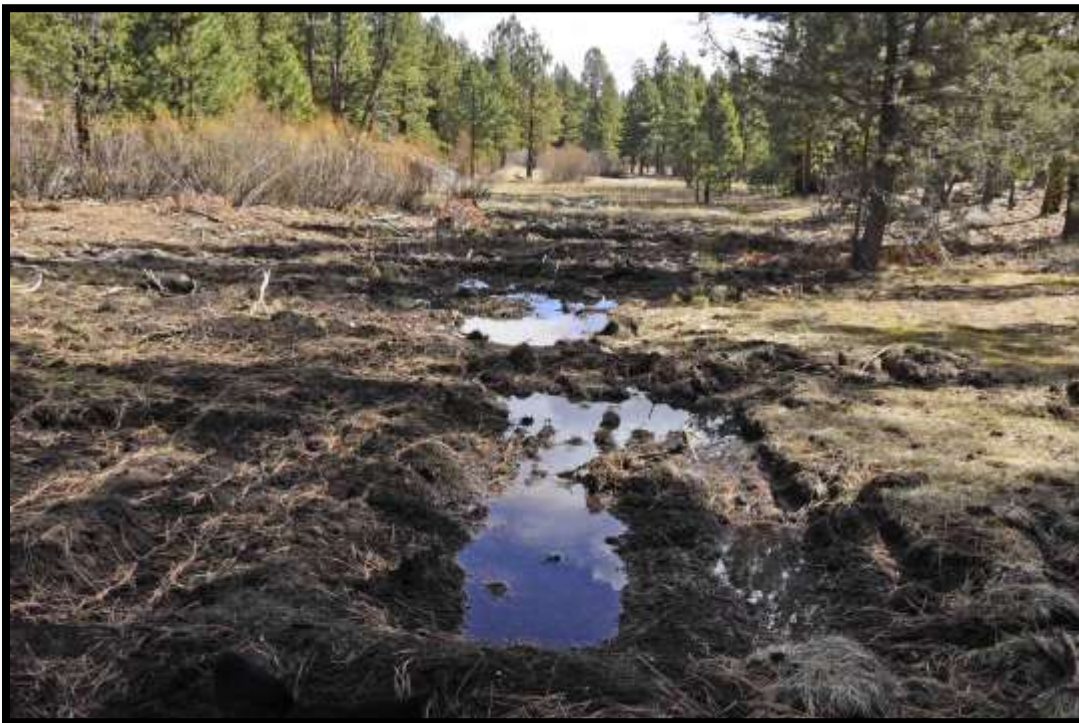
**South Log Grade Control Structures Effectively Detaining and Ameliorating Retained Spring Pond Outflow and Preventing Erosion March 2020 (Mid-Slope) (View W)**

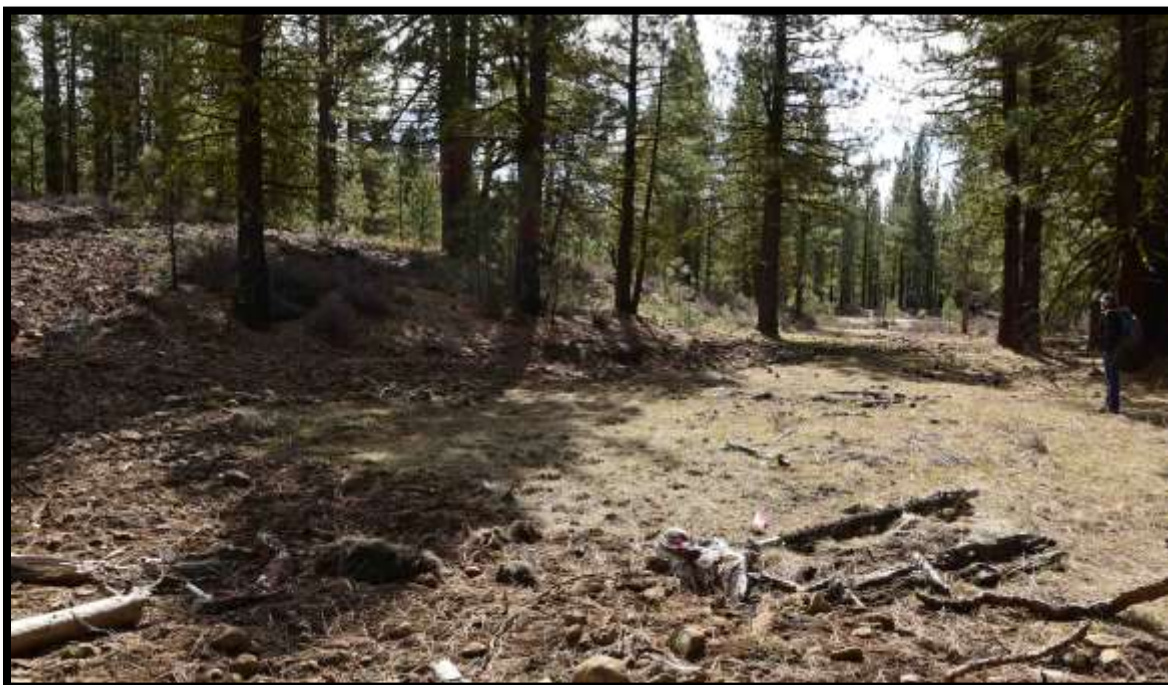
**Photo Monitoring Station #3 Borrow Access March 2020 (View SE)**

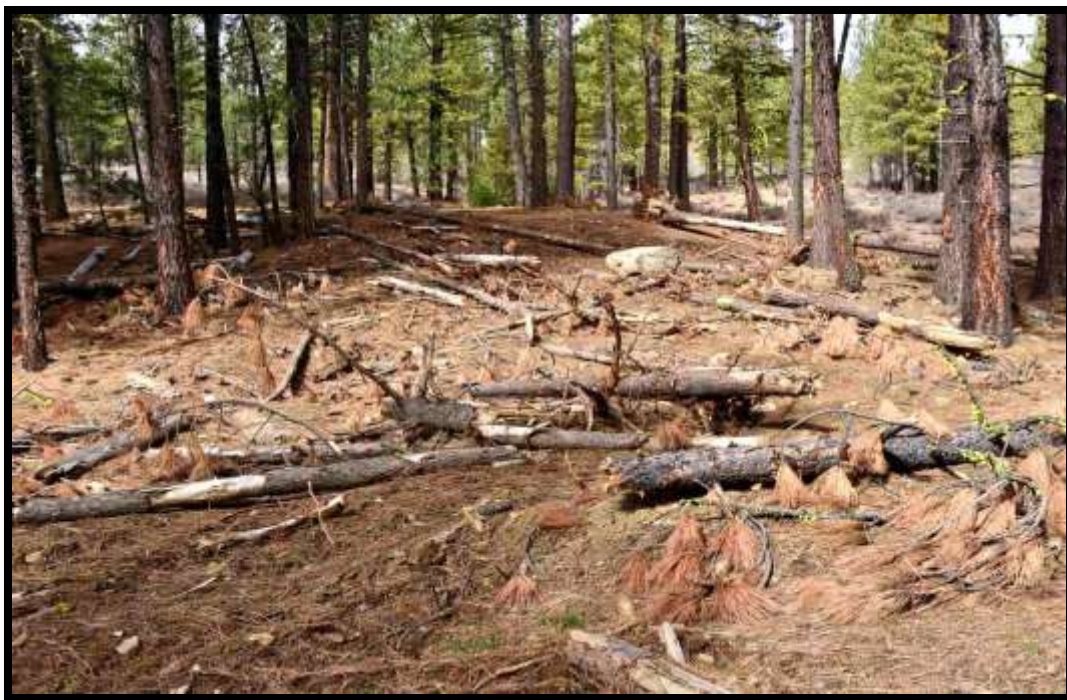
**Photo Monitoring Station #4 and Borrow Site Rehabilitation March 2020 (View NW)**

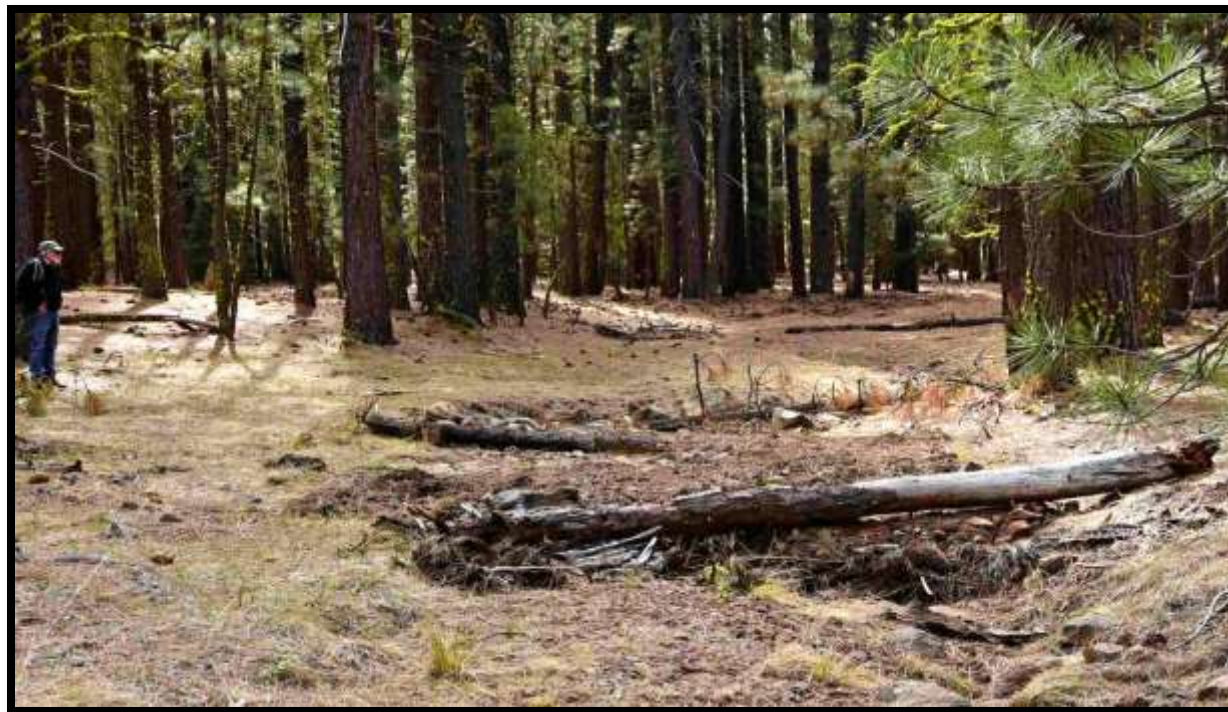
**Photo Monitoring Station #5 Rock and Log Grade Control March 2020 (View S)**

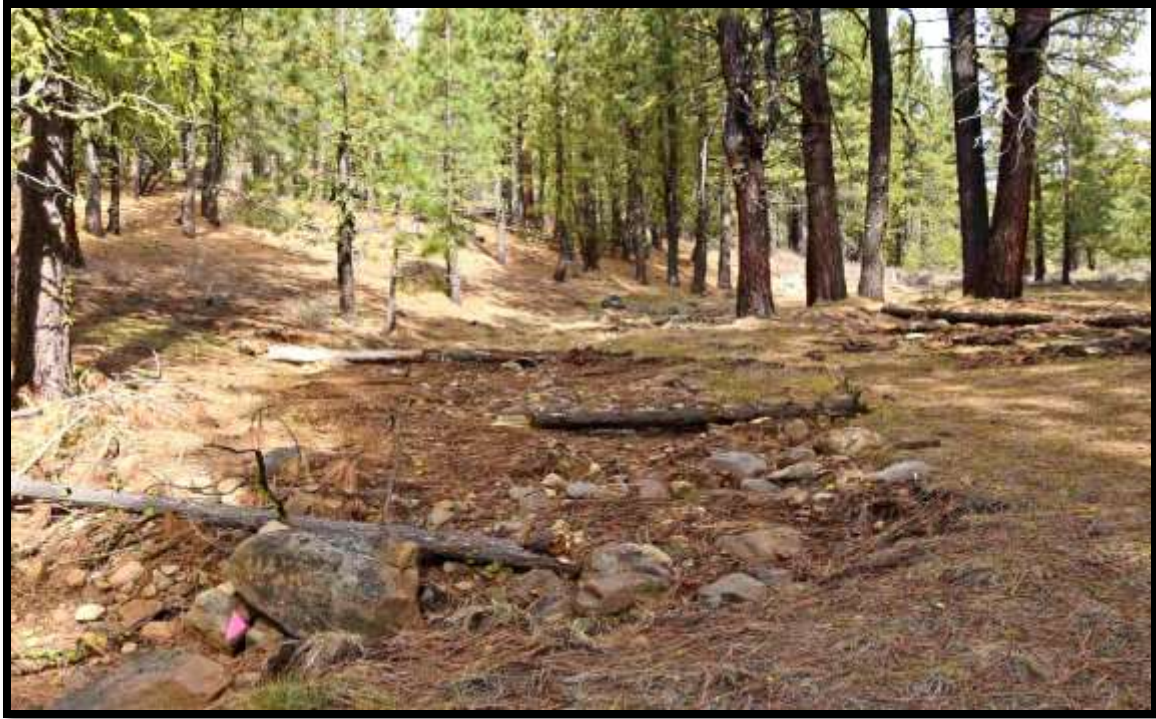
**Photo Monitoring Station #5 Rock and Log Grade Control March 2020 (View N)**

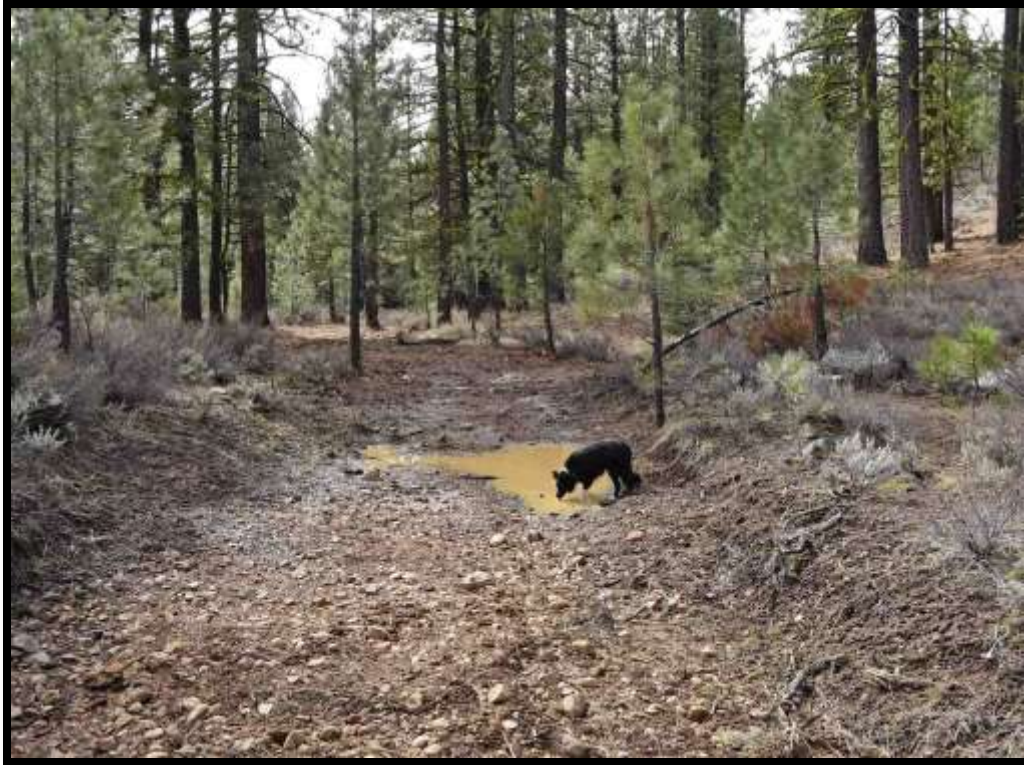
Surface water was not observed at Site #8 during early season monitoring (February-March 2020); however, a small seep in the north project area was releasing water onto the filled gully with no erosion observed.

**Photo Monitoring Station #6 Seep March 2020 (View S)**

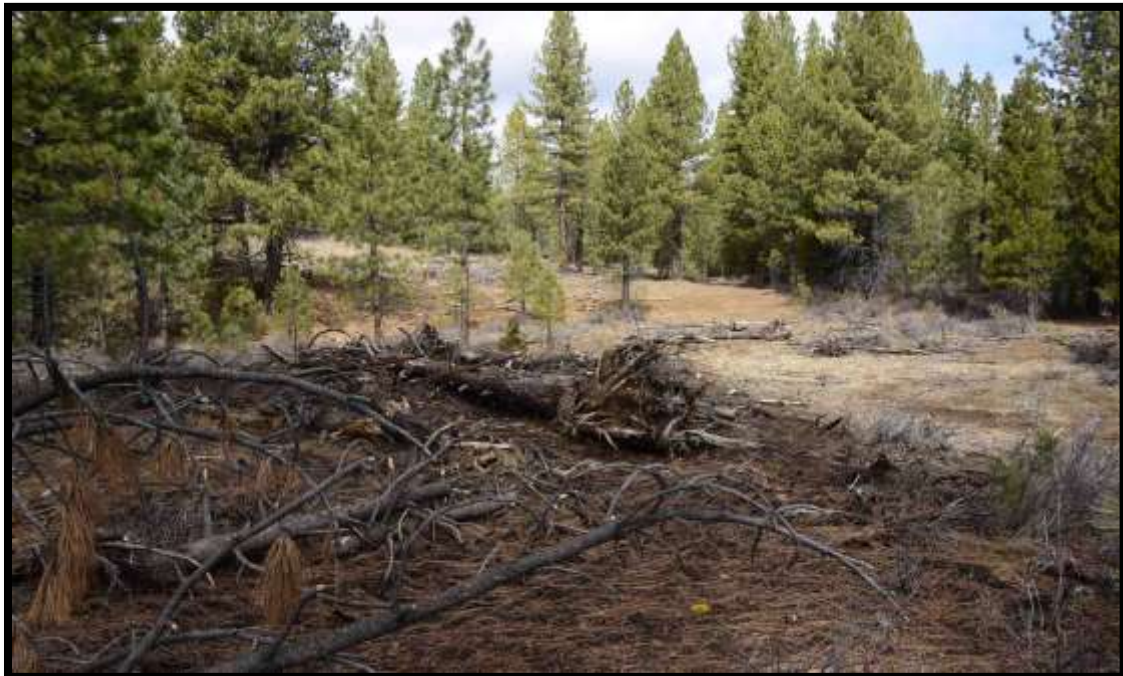
**Photo Monitoring Station #7 Road Rehabilitation and North Borrow Area March 2020 (View NW)**

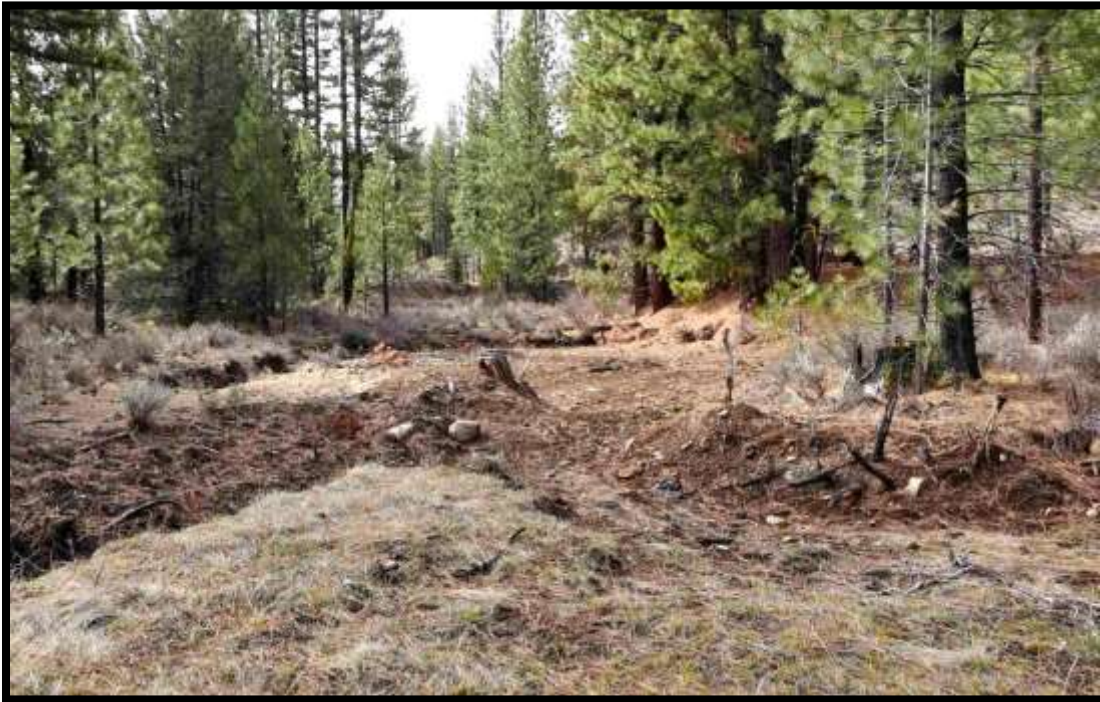
**Photo Monitoring Station #8 North Meadow Log Grade Control February 2020 (View SW)**

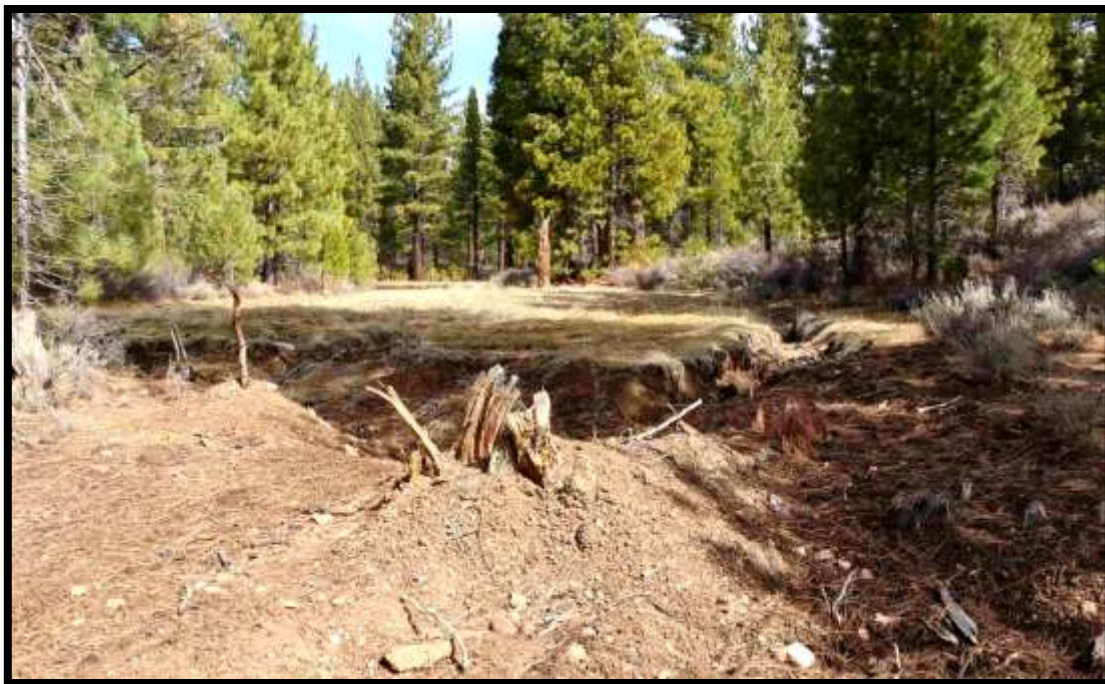
**Photo Monitoring Station #8 North Meadow Log Grade Control March 2020 (View NE)**

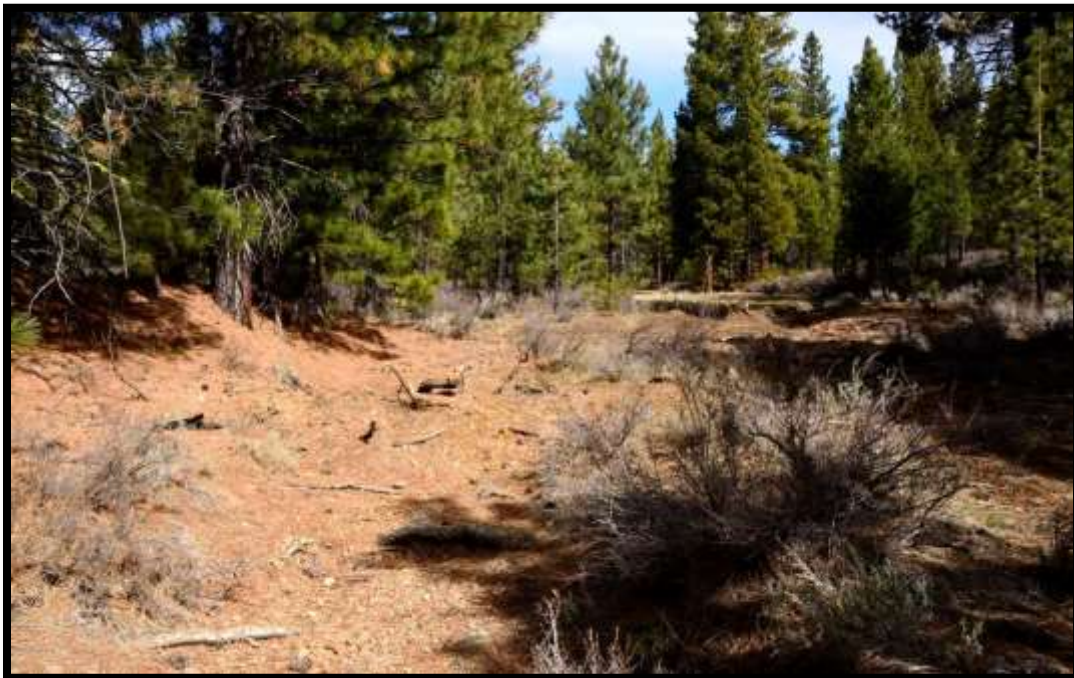
**Log Grade Control #1 and Adjacent Degraded Meadow March 2020 (View N)**

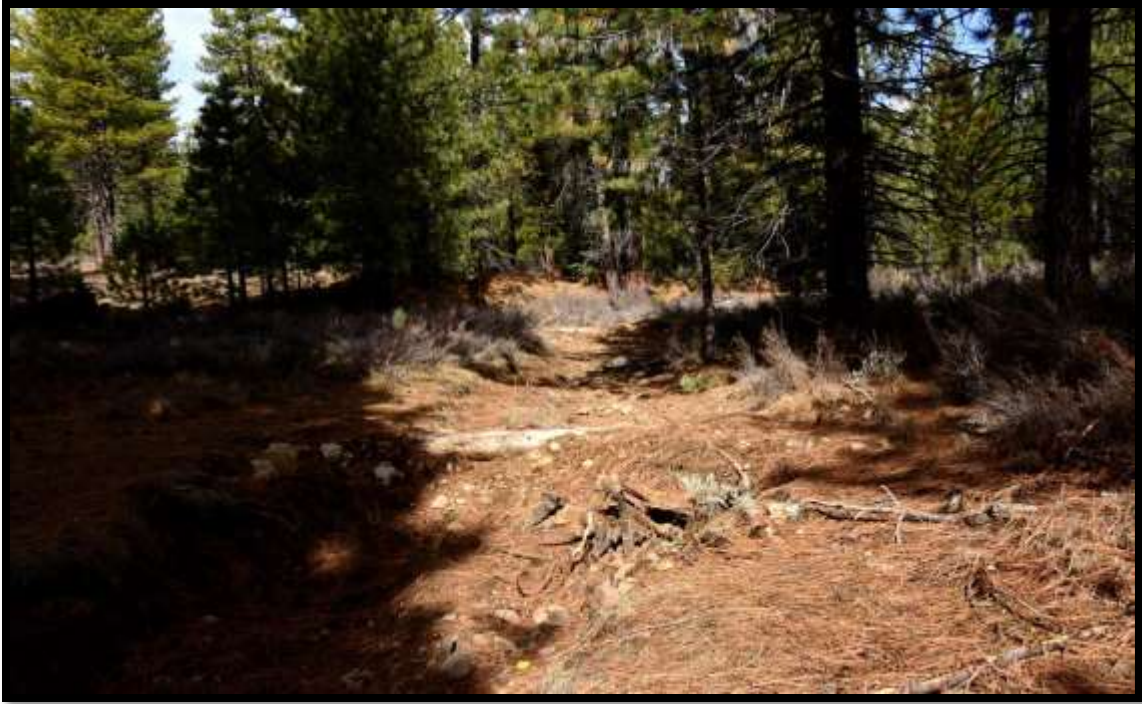
**Log Grade Control #2 and #3 in Meadow Gully March 2020 (View N)**
