**CARMAN WATERSHED RESTORATION PROJECT PHASE 2  
POST-PROJECT and ADAPTIVE MANAGEMENT  
MONITORING REPORT**

**SITES 1, 2, 4, AND 8**

**(California Department of Fish and Wildlife Watershed Restoration  
Grant Program Agreement #P1796015)**

**March 2020**

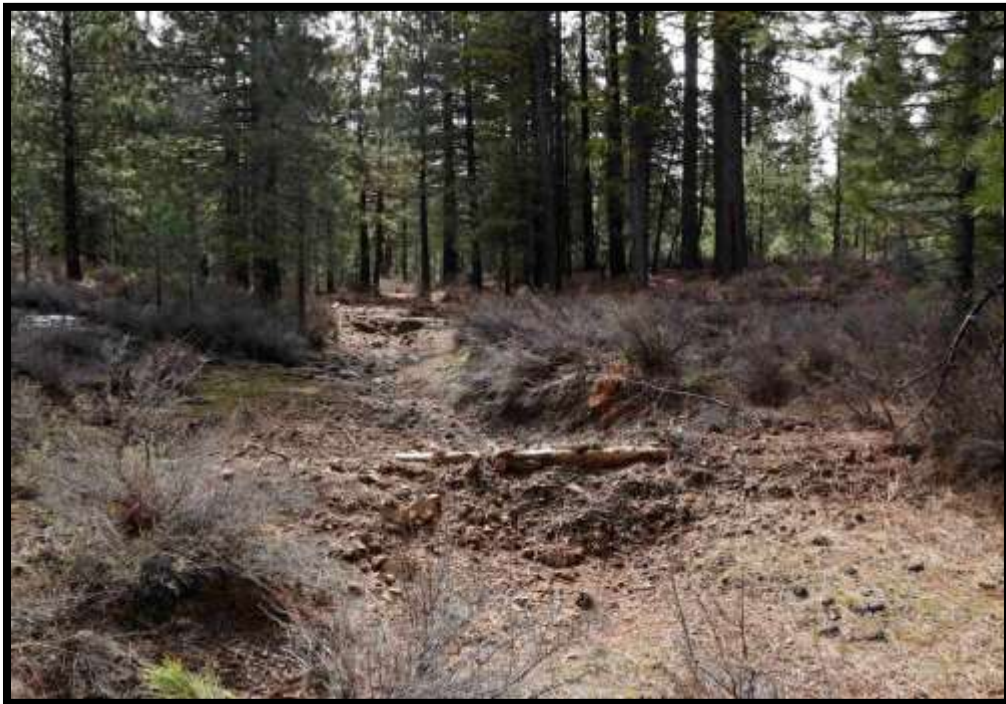
**Log Grade Control #2 and #3 in Meadow Gully March 2020 (View S)**

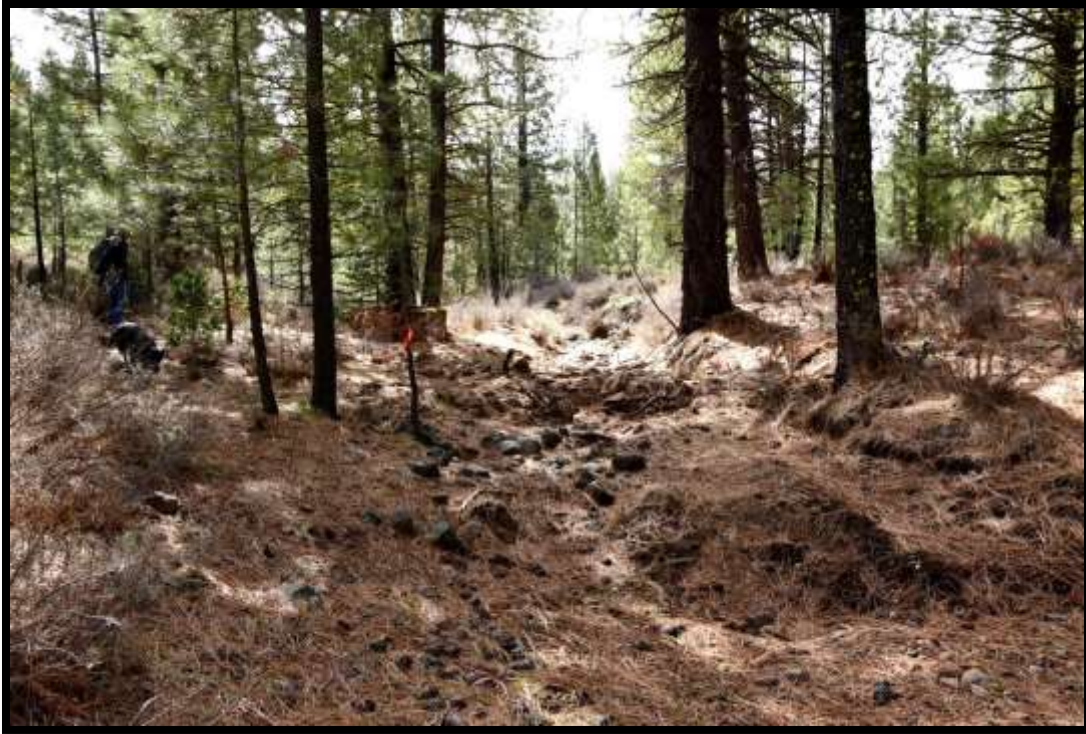
**Log Grade Control #4 in Meadow Gully March 2020 (View S)**

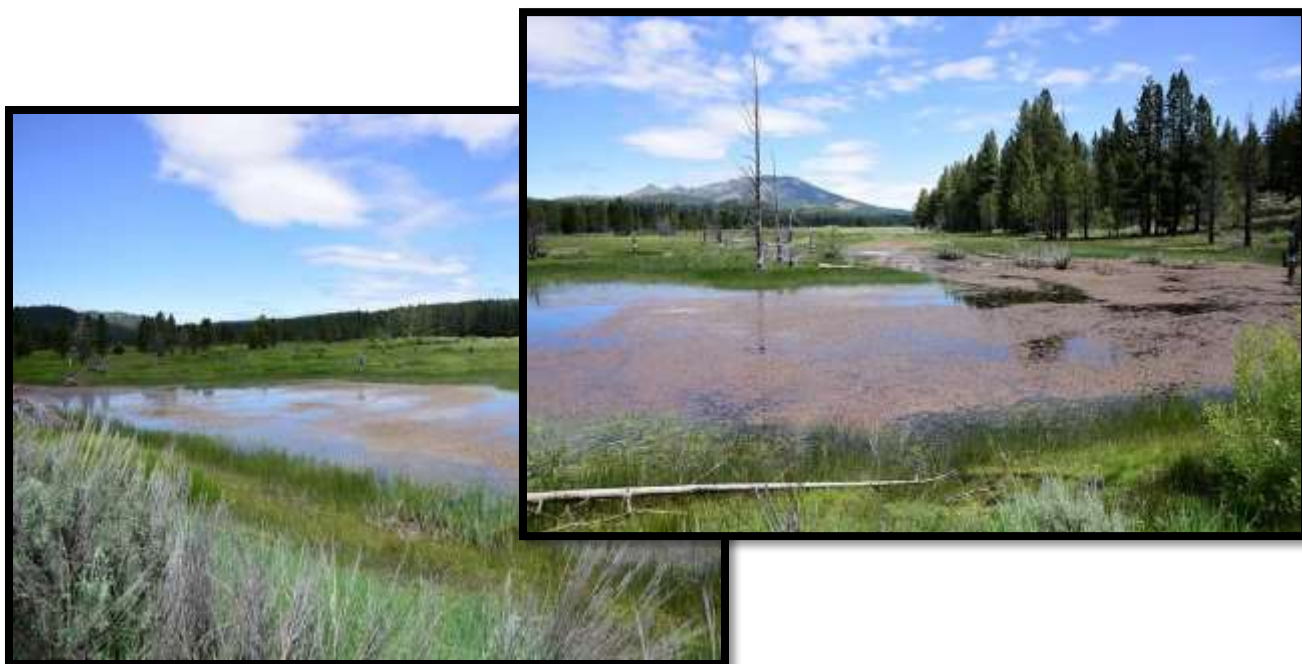
**South Open Water Area/Emergent  
June 2018 (View N)**

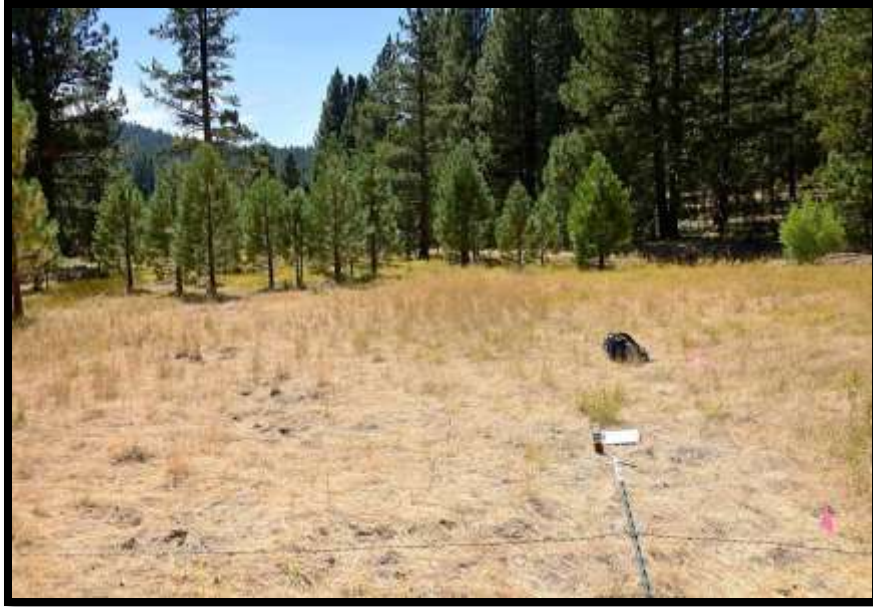
**PM #1 - Degraded Meadow Just South of North Fence May 2019  
(View SE)**

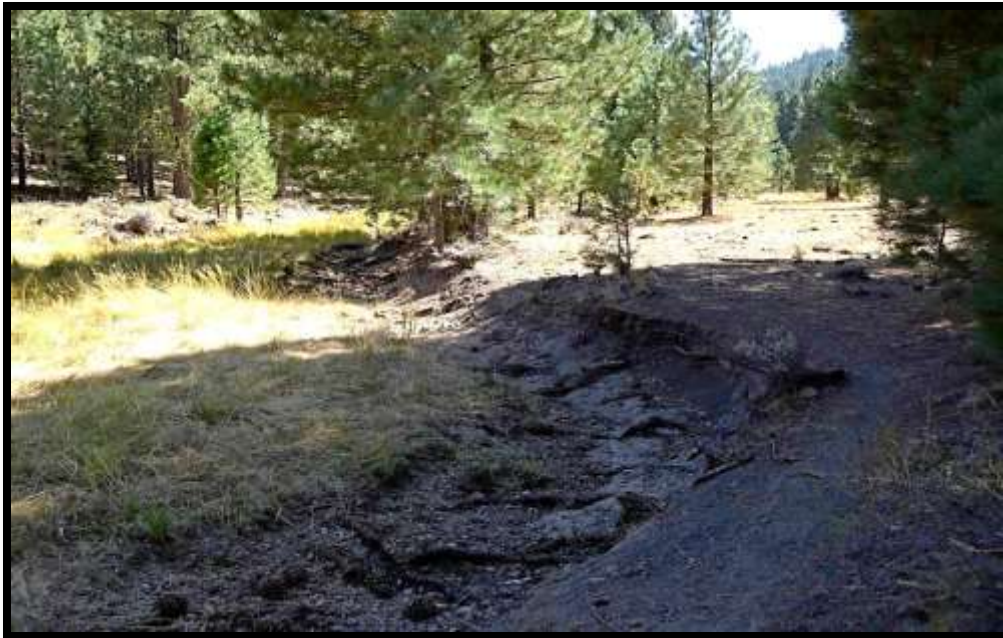
**PM #2 – Gully Erosion and Meadow Degradation May 2019 (View N)**

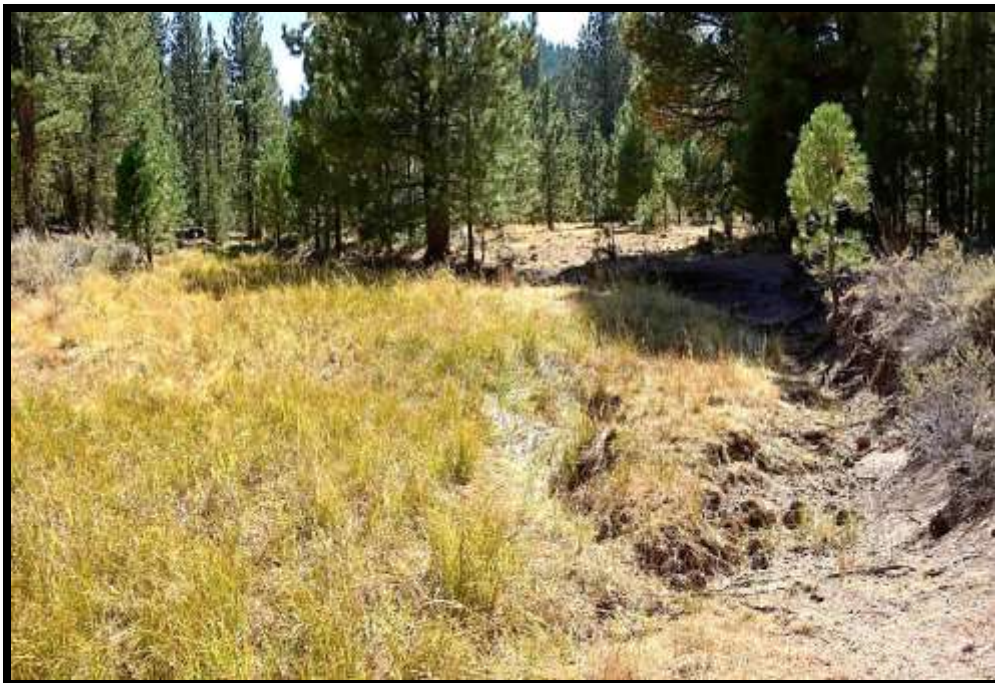
**PM #2 – Gully Erosion and Meadow Degradation (View S)**

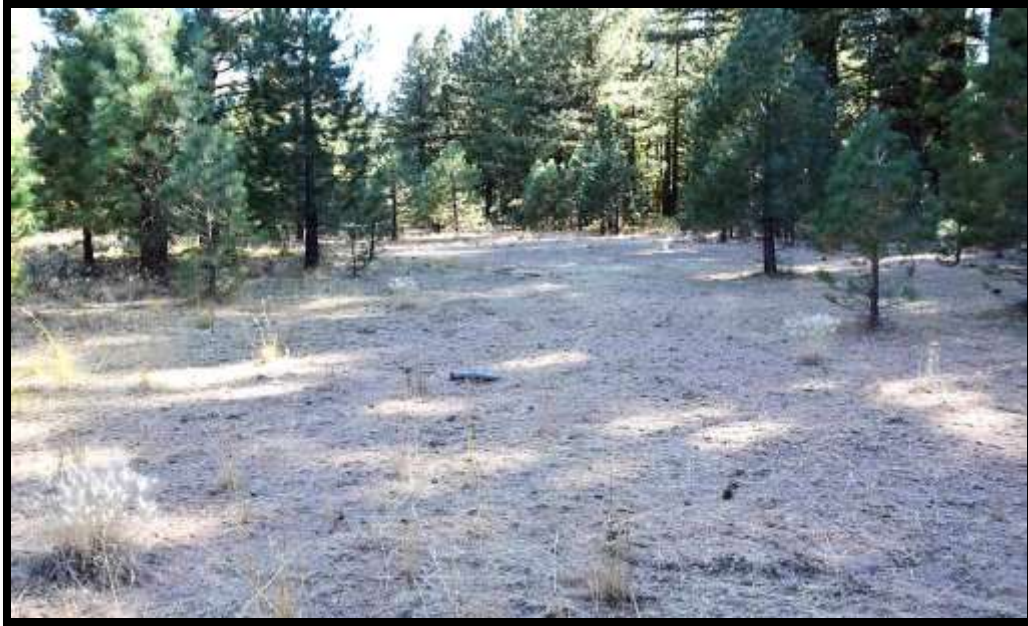
**PM #3 - Degraded Meadow Floodplain May 2019 (View N)**

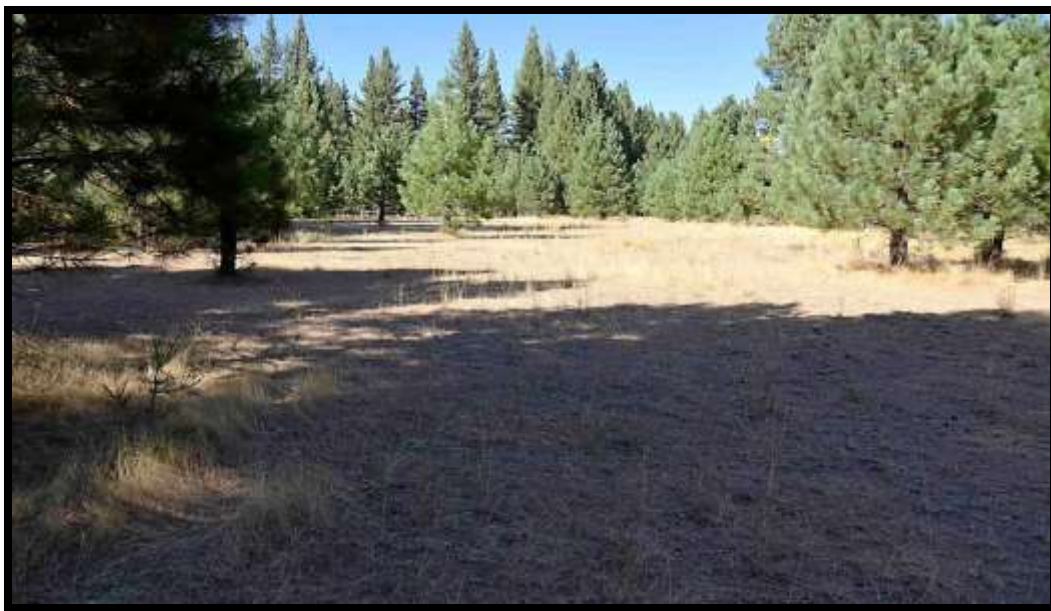
**PM #3 - Degraded Meadow Floodplain (View S)**

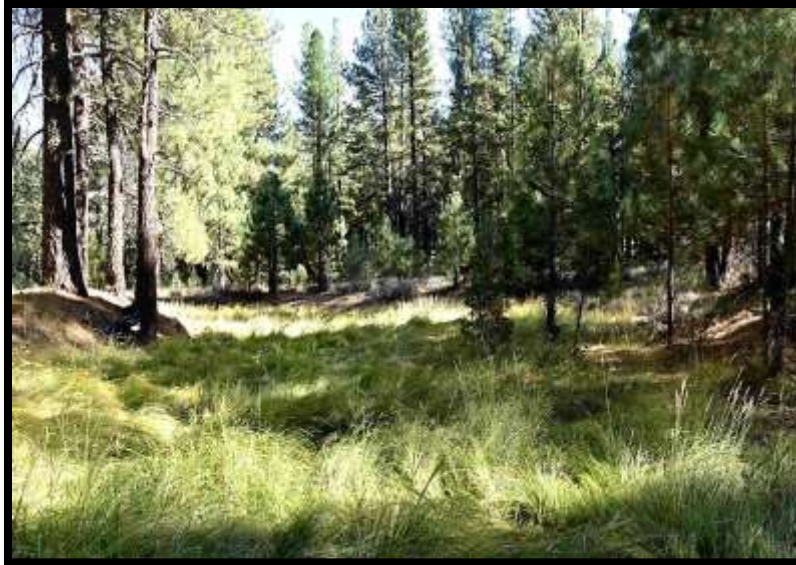
**PM #4 - Vegetated Gully  
Supported By Ground Water  
May 2019 (View SE)**

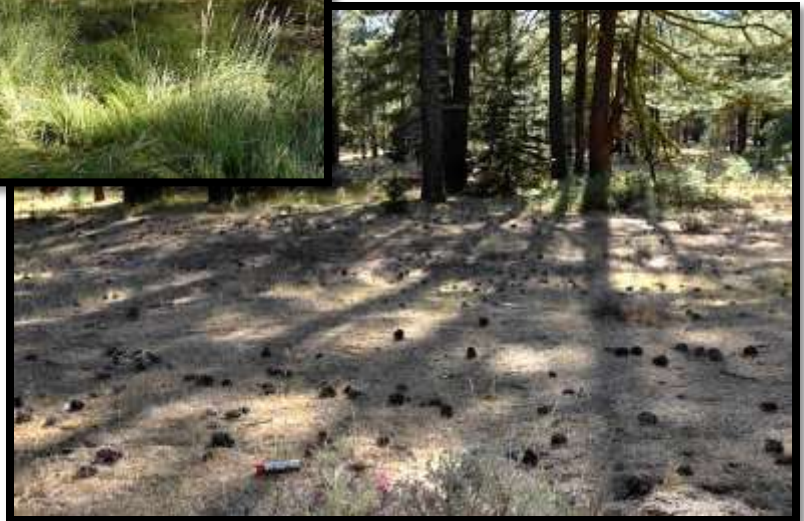
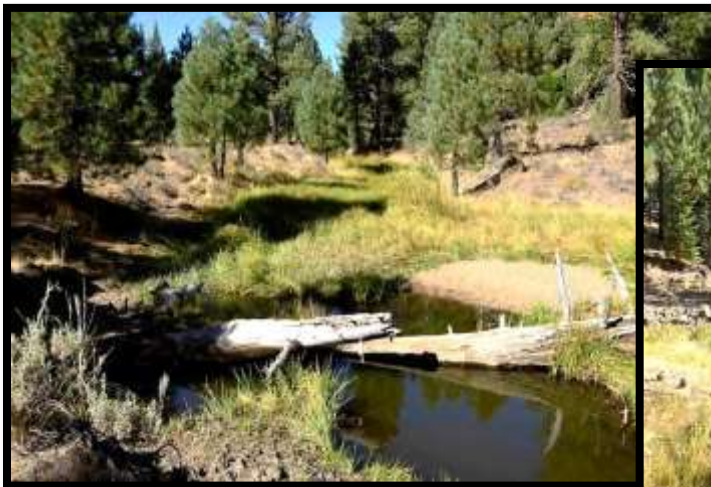
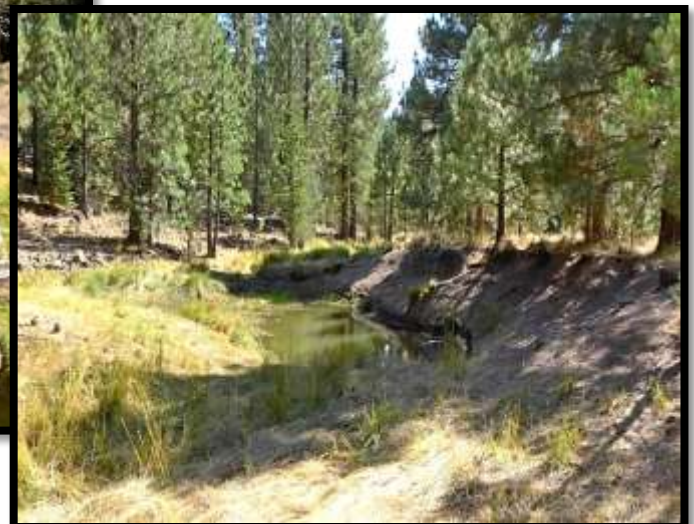
**Site #4 - Gully Erosion with 6-Foot High  
Exposed Banks and Bottom  
Ponding/Saturation Supported by Groundwater Interception May 2019 (View S)**

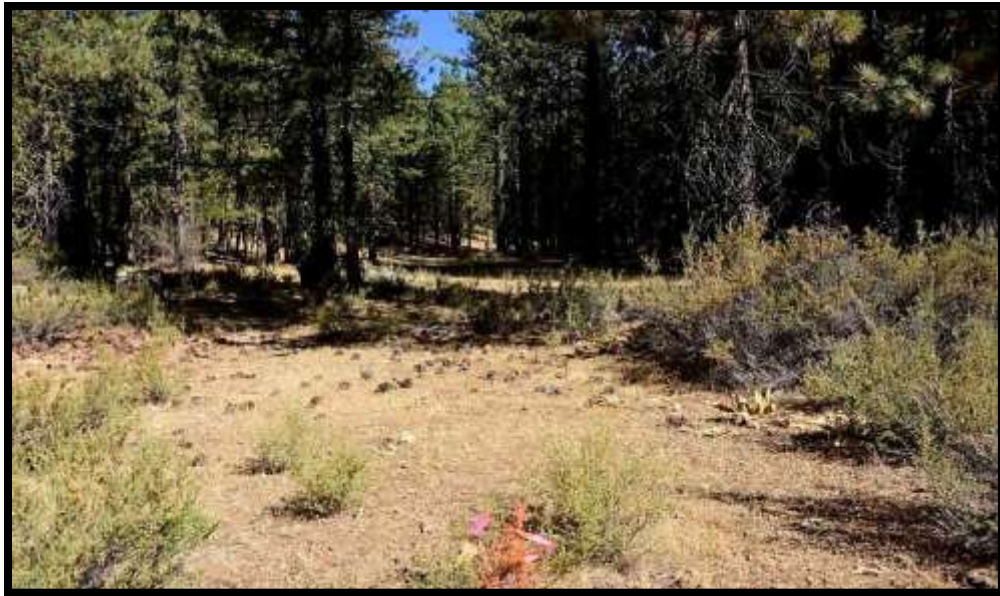
**PM #1 – Degraded Meadow  
June 2018 (View N)**

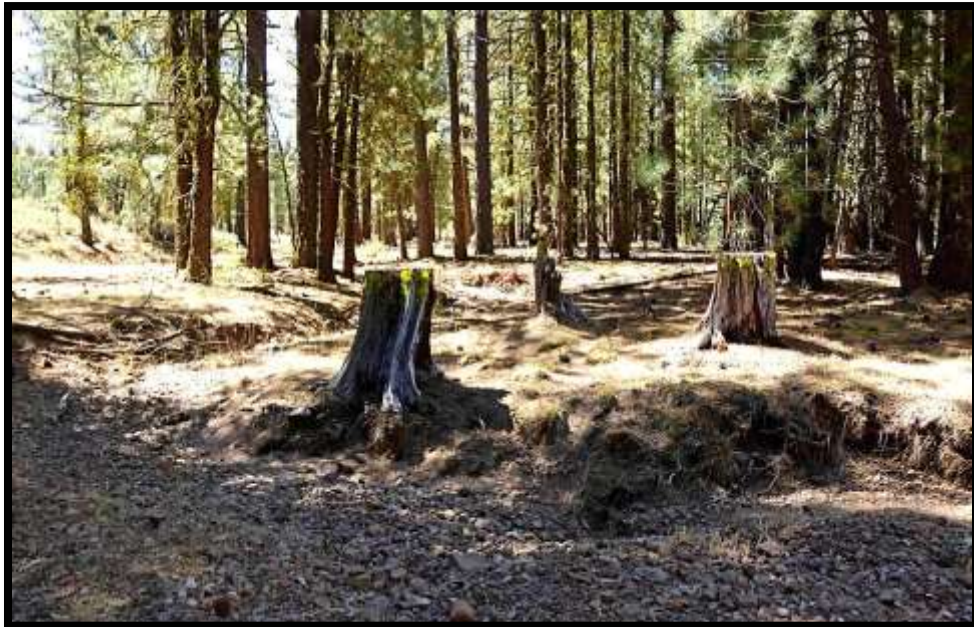
**PM #2 – Gully Erosion and Degraded Meadow  
(View N)**

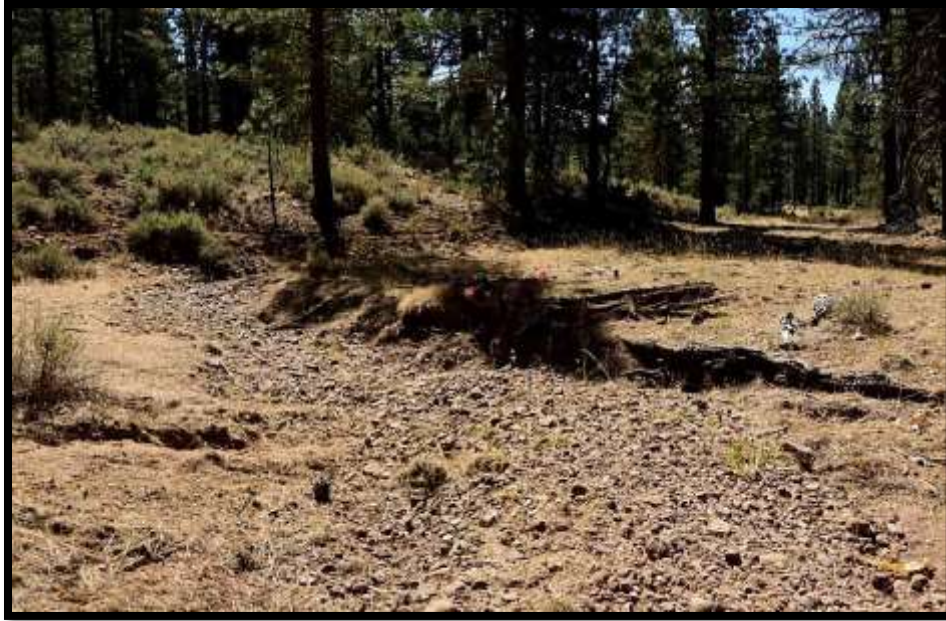
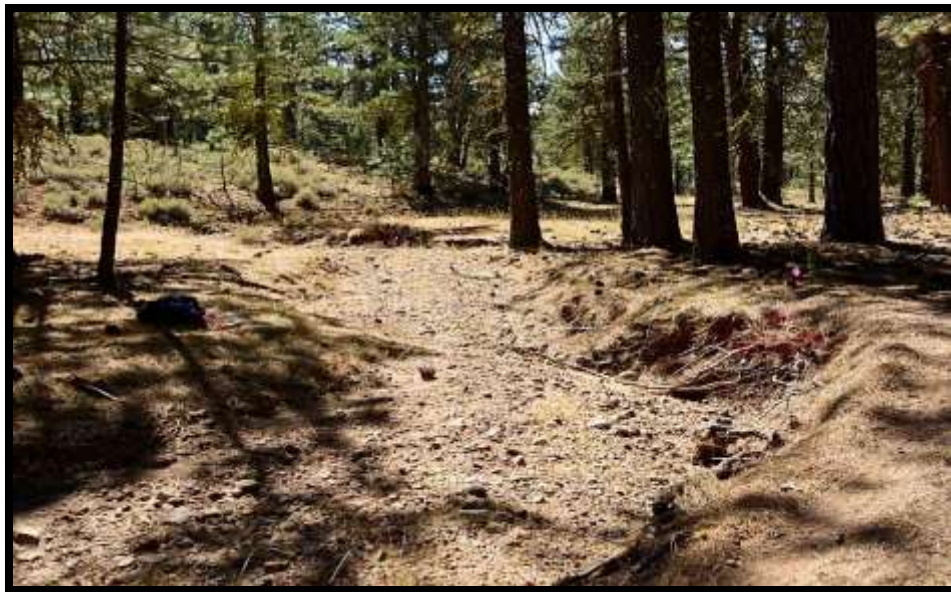
**PM #4 – Eroded Gully/Degraded Meadow and Forested/Sagebrush Borrow Area  
June 2018 (View S)**

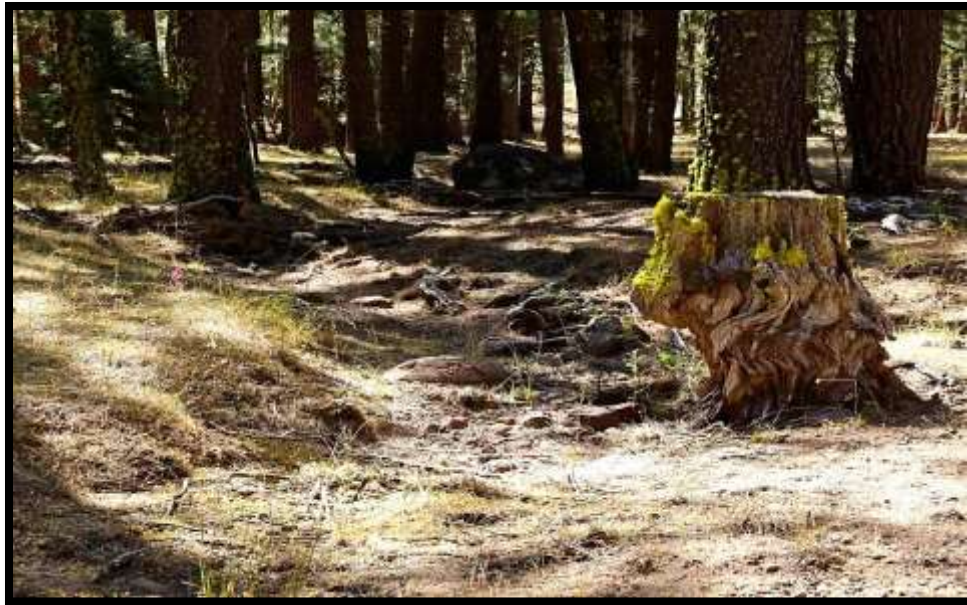
**PM #5 – Broad Rocky Gully Swale And Degraded Meadow  
June 2018 (View NE)**

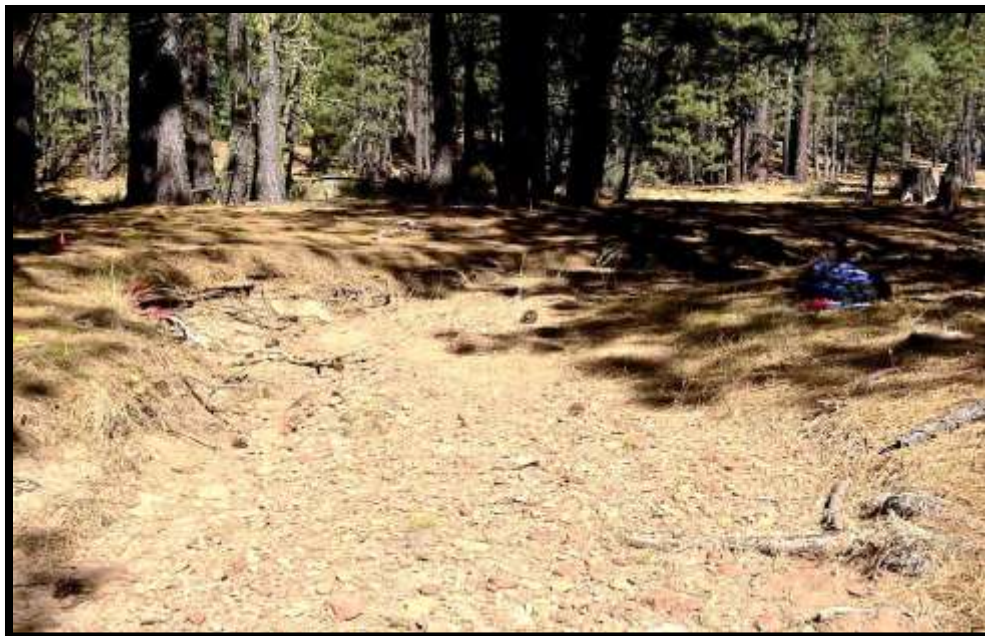
**PM #6 – Gully Erosion  
(View N)**

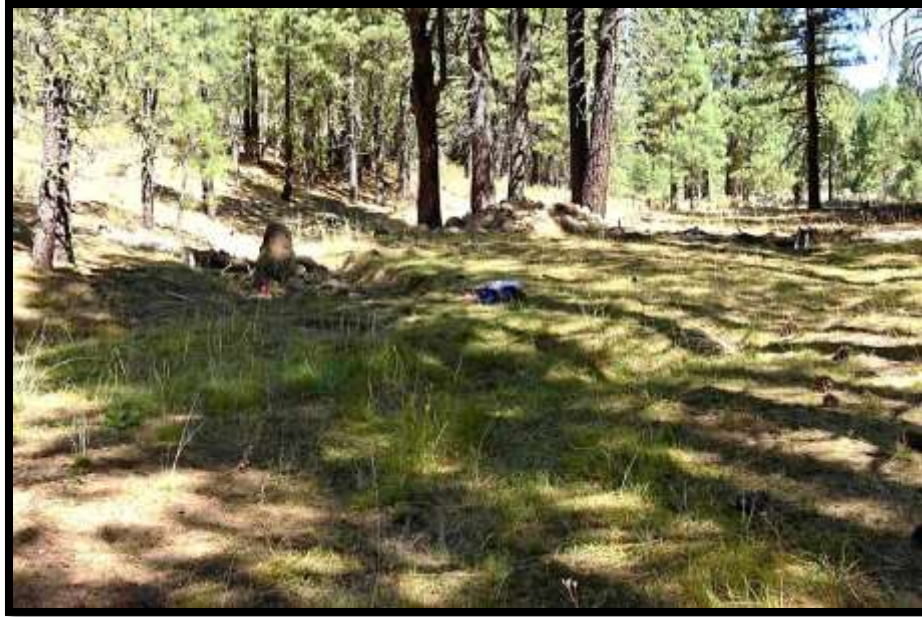
**PM #7 – Gully Erosion and Degraded Meadow  
June 2018 (View NE)**

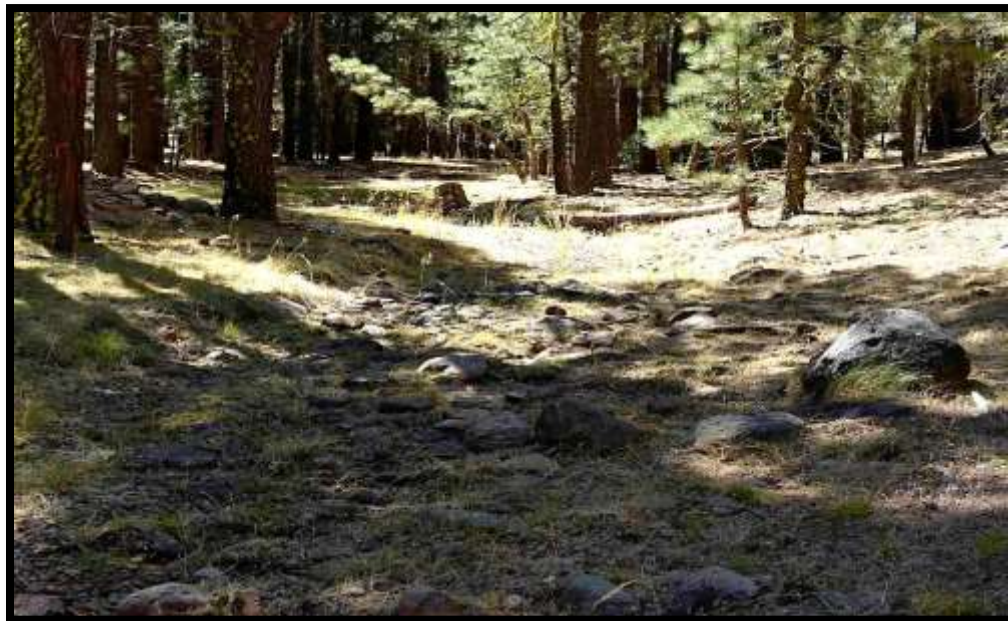
**PM #7 – Degraded Meadow  
(View S)**

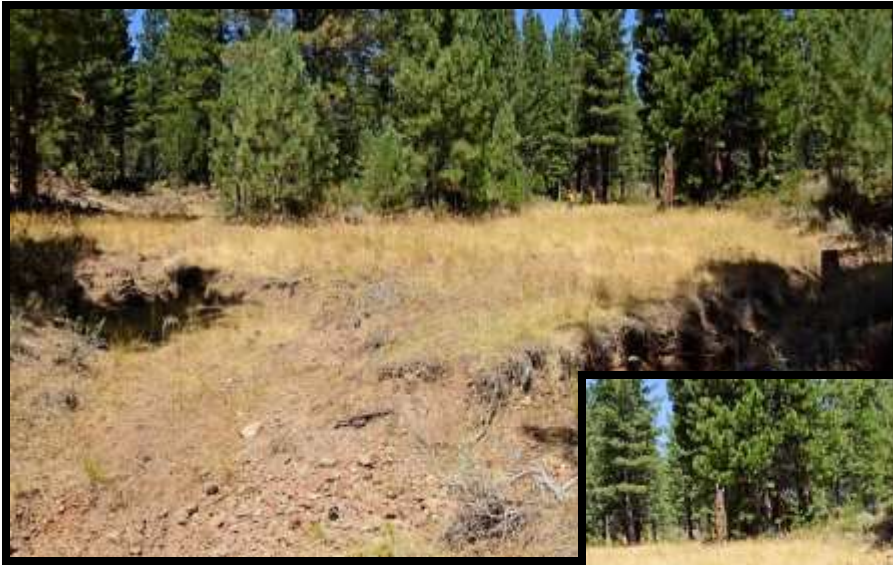
**PM #8 - Degraded Upper Meadow  
With Deep Gully Incision  
July 2019 (View E)**

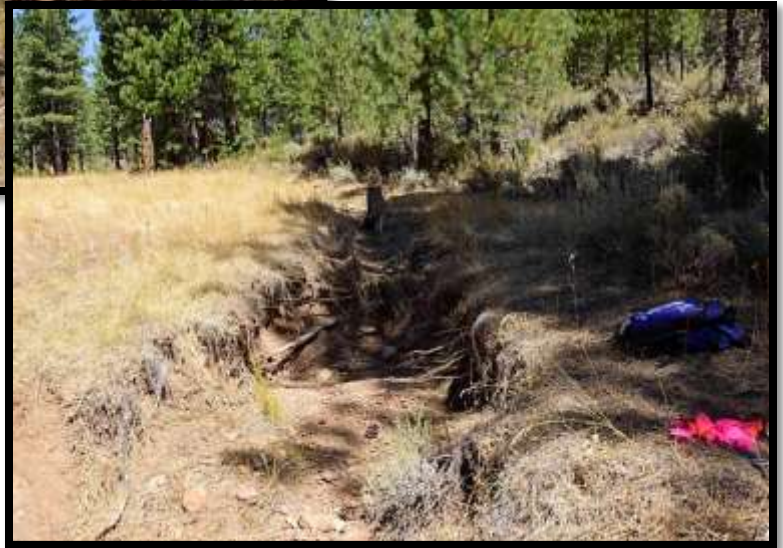
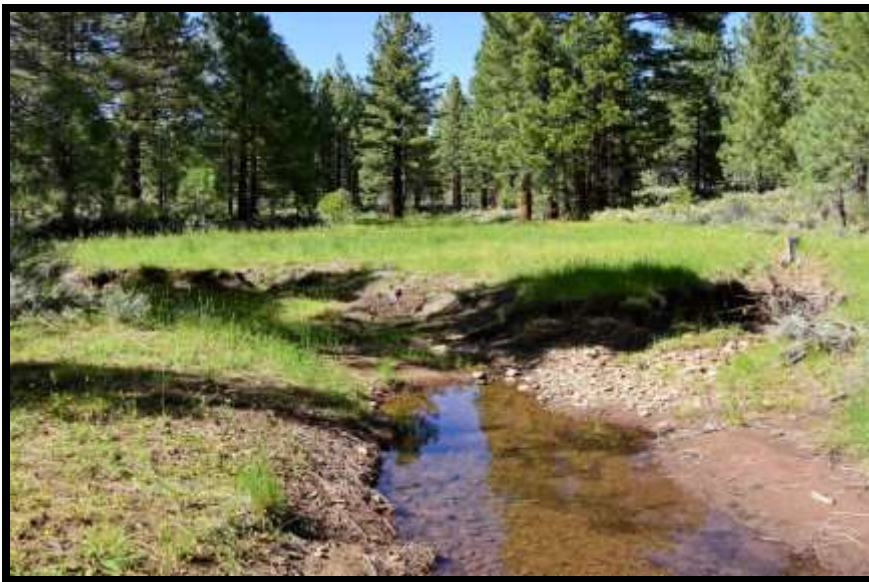
**PM #8 - Degraded  
Meadow Gully  
Erosion with Spring  
Flow  
May 2019  
(View E)**

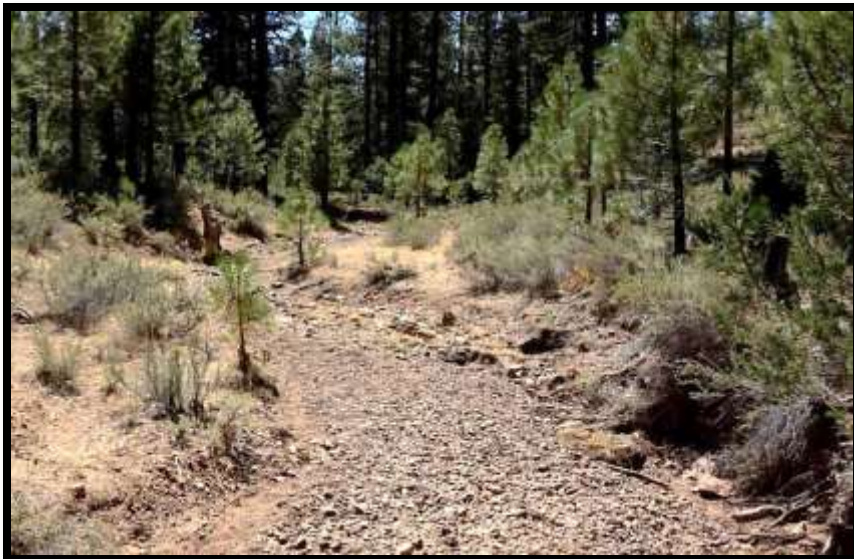
**North Project Area  
East Gully Erosion  
(Typical)  
June 2018 (View S)**
