Assessment Data and Results for Alder Creek

This document includes the results and data collected from all of the protocols completed at Alder Creek. The first two pages are a map of Alder Creek, showing the locations of all assessments, by protocol and then showing the standardized rating. The third page is an overview table for all protocols including the assessment output, our standardized rating, and the factors identified that went into the rating. The following pages are the data sheets and/or summary results of each protocol.

GDE Level I Inventory Assessment Summary: Alder Creek Meadow

Alder Creek Meadow - Meadow Assessment Comparison Project Survey Summary Report, Springs Online Site ID 250064

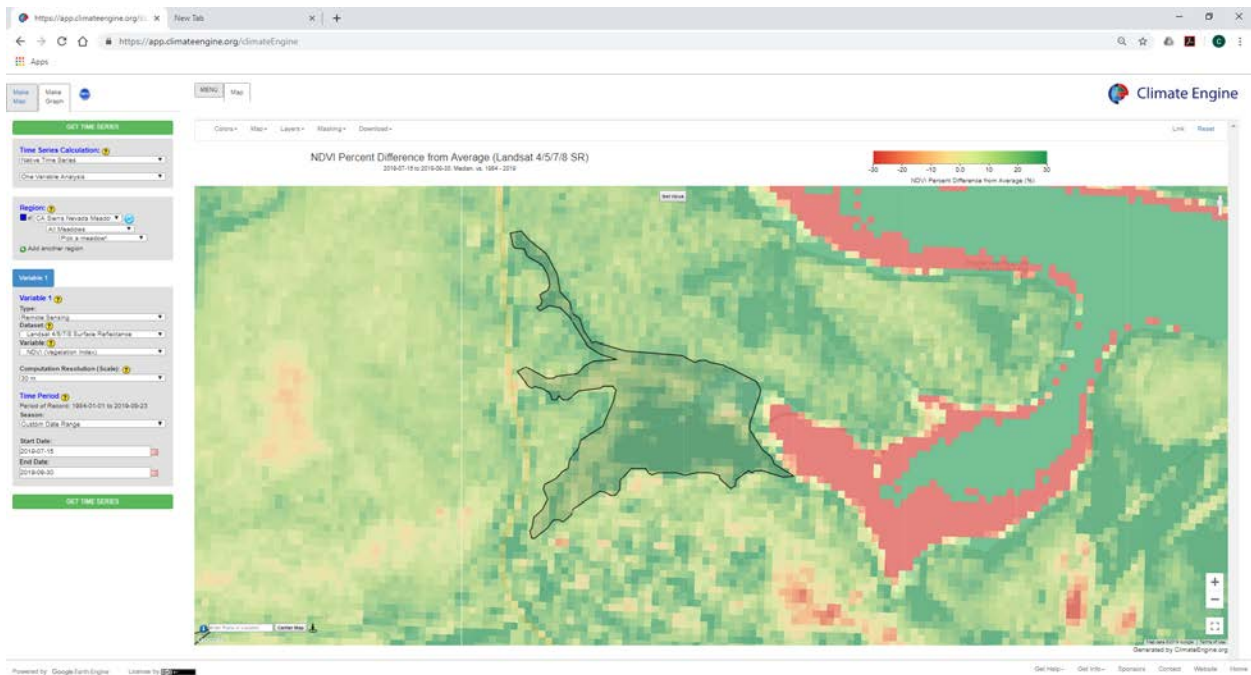
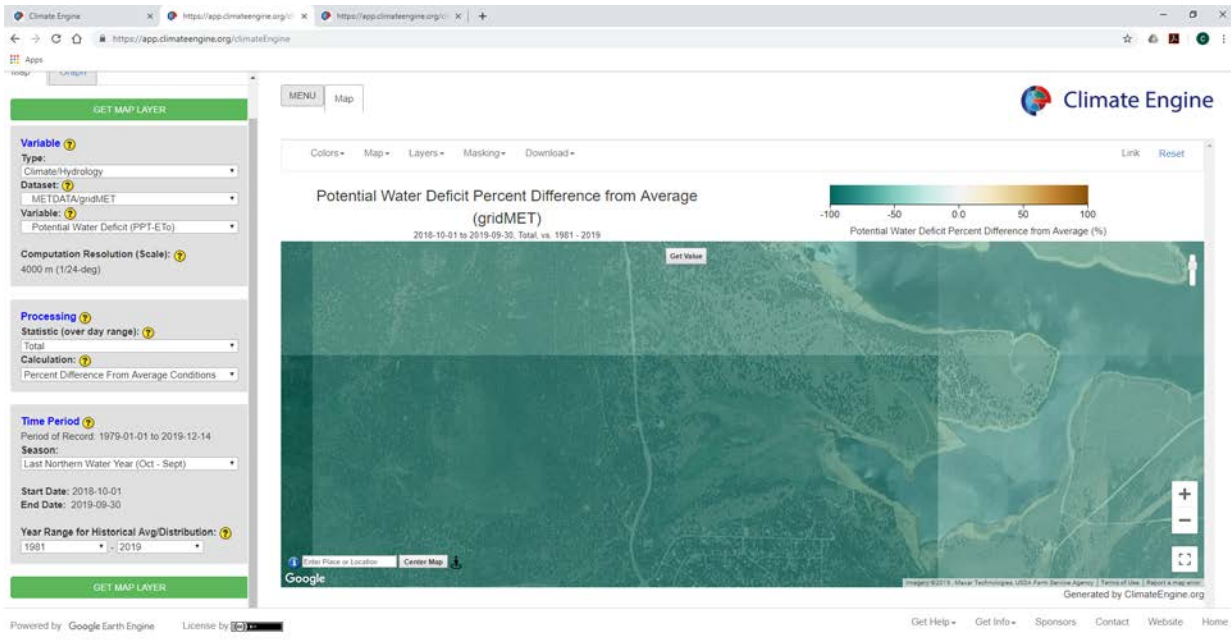
Status Assessment:

Relative to the historical (1984-2019 record), late summer (July 15-Sept 30) 2019 **NDVI is higher than average in most parts of the meadow, due to the above normal water year.** This is the expected relationship. The northern and western periphery of the meadow show smaller anomalies than the central/southern, potentially indicating differences in responses to climate within the meadow or potentially indicating places where drying is occurring over time (lower anomaly areas). Beaver activity was observed in the greener area, which may explain this result. Similarly, extensive downcutting was observed in the northern part of the meadow which may also be playing a role. The red area outside the meadow and along the periphery of the reservoir indicates water levels are higher than average (water has a very low NDVI value).

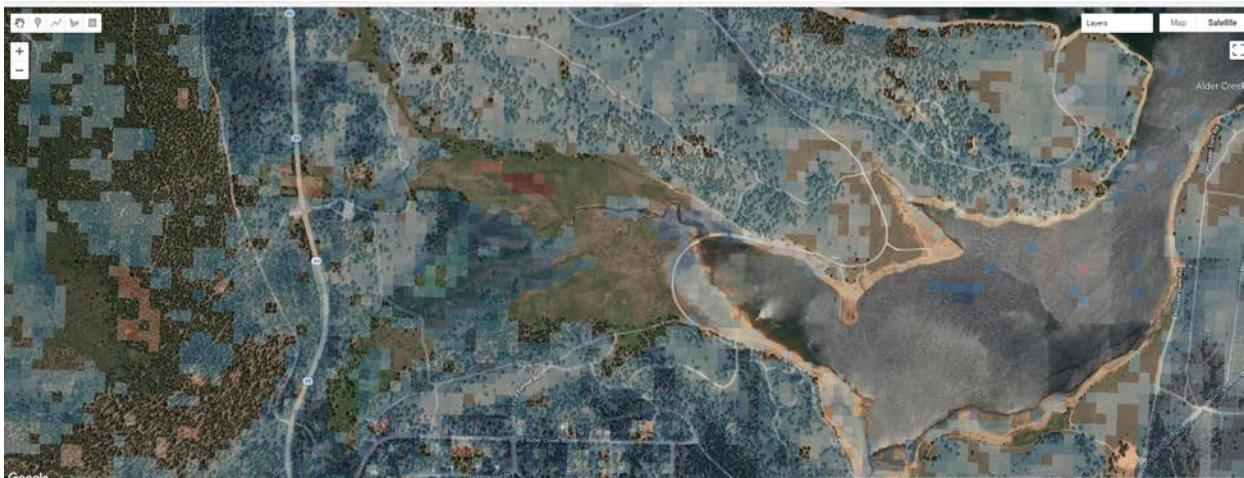
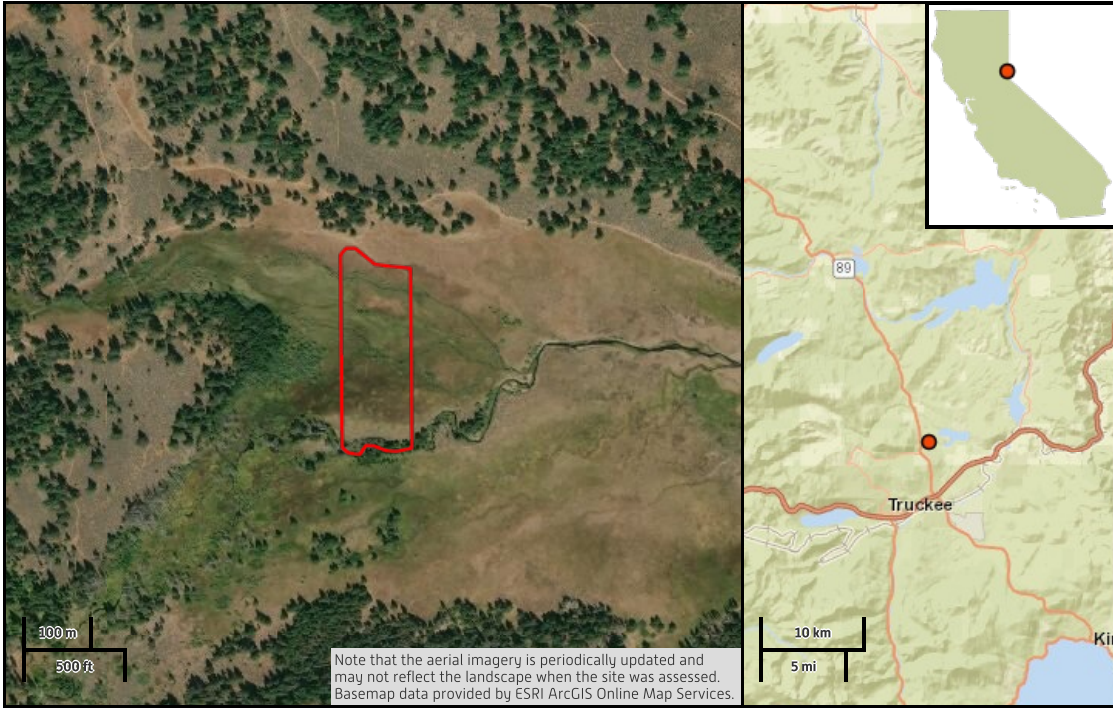
Trend Assessment (note that this capability is coming soon to Climate Engine but is not yet available):

1984-2018 trend in median July-Sept NDVI (red=declining NDVI, blue=increasing NDVI, no color= trend not significant): Much of the meadow exhibits no trend, but the **area around reach start generally is increasing in trend, same with inlet into Prosser Reservoir. Small area to north showing decreasing trend.** The increasing trend around the Reservoir inlet likely suggests overall declines in water levels surrounding the reservoir over time (soil/vegetation have higher NDVI than water), despite relatively high water levels in 2019 (shown in status assessment). Other areas of dark blue may indicate effects of beaver activity over time resulting in increased water retention. The small red patch indicates declining vegetation cover/condition. This area was investigated in the field and could be due to overall drying of the fen-like conditions that occur here. A small number of dead trees were also found here that may also explain this decline. The lack of trend in the rest of the meadow does not necessarily indicate static conditions, rather it indicates a lack of consistent upward or downward trending over the 1984-2019 time period that was analyzed. The area surrounding the meadow is generally trending upward, indicating increase vegetation cover/vigor, and increased forest water use that has the potential to affect water availability in the meadow.

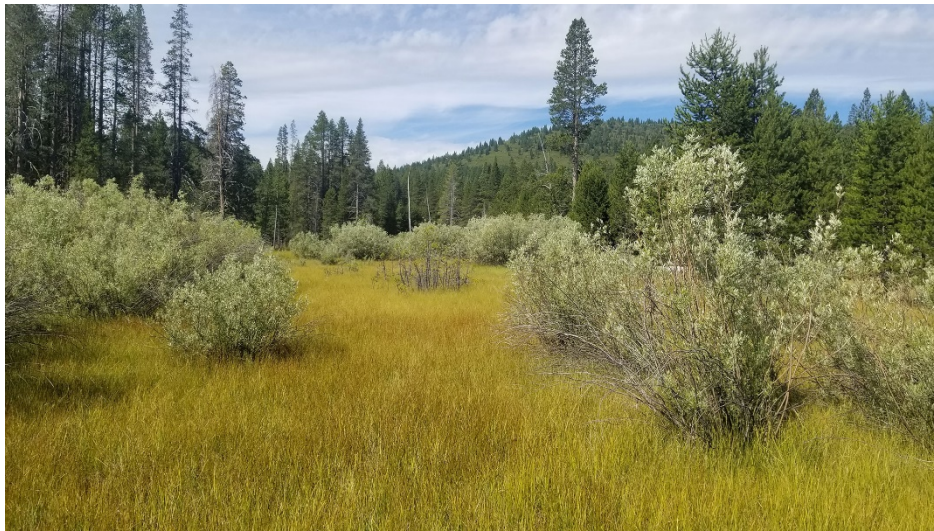
Fig 1.1 Alder Creek Meadow: Center of site upslope

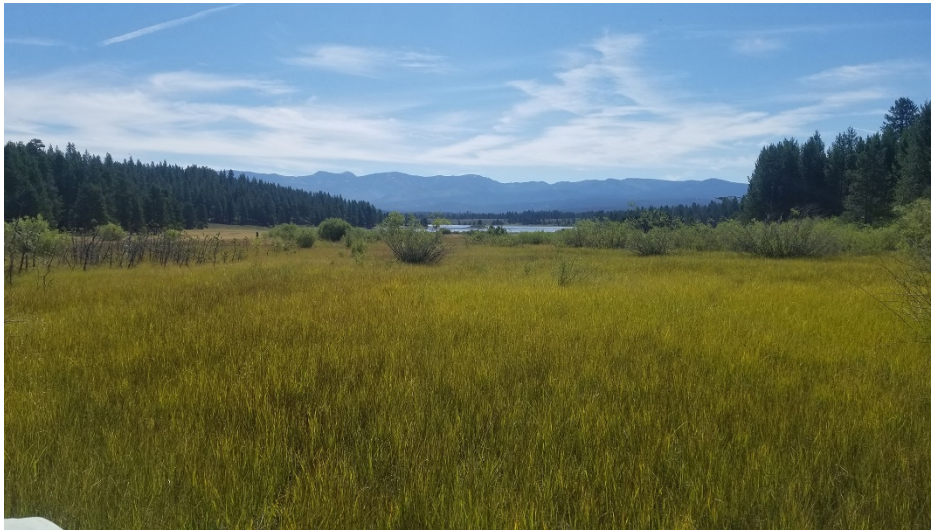
Fig 1.3 Alder Creek Meadow: Center of site downslope

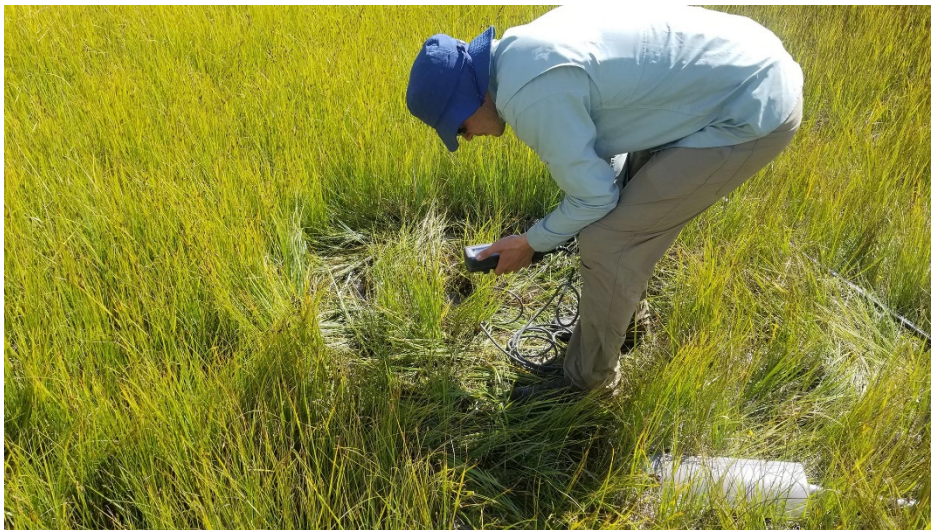
Soil condition: At the augured hole, peat was identified down to a depth of 43 cm where there was a transition to mineral soil. Fen characteristics, including the presence of a histosol, were observed.

Fig 1.4 Alder Creek Meadow: Soil core location

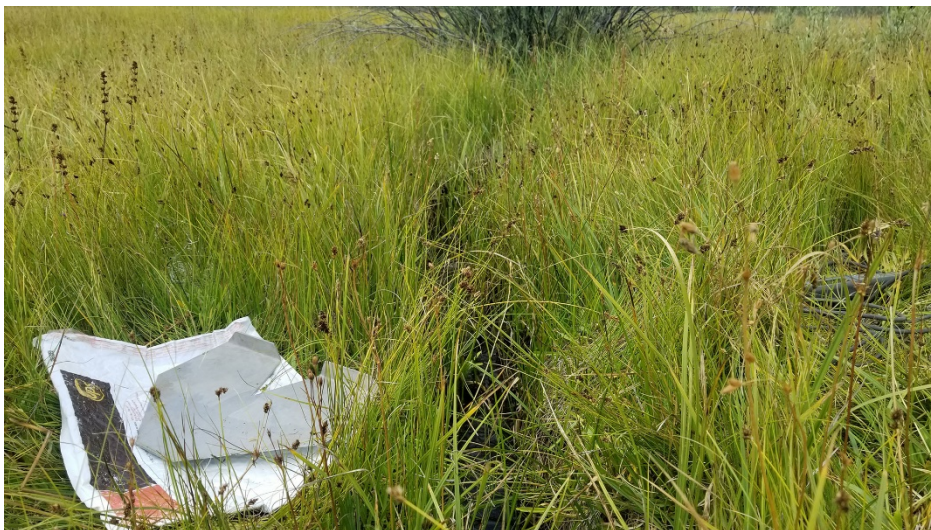
Flow: Surveyors measured a flow of 0.1 liters/second, using a v-notch weir. Flow was adjusted for an estimate of 95% of site flow capture. Inflow channel This spring is perennial, with a neoregion persistence. The site was Groundwater inflow dominated, and both groundwater and surface water outflow significant.

Fig 1.5 Alder Creek Meadow: Spring source

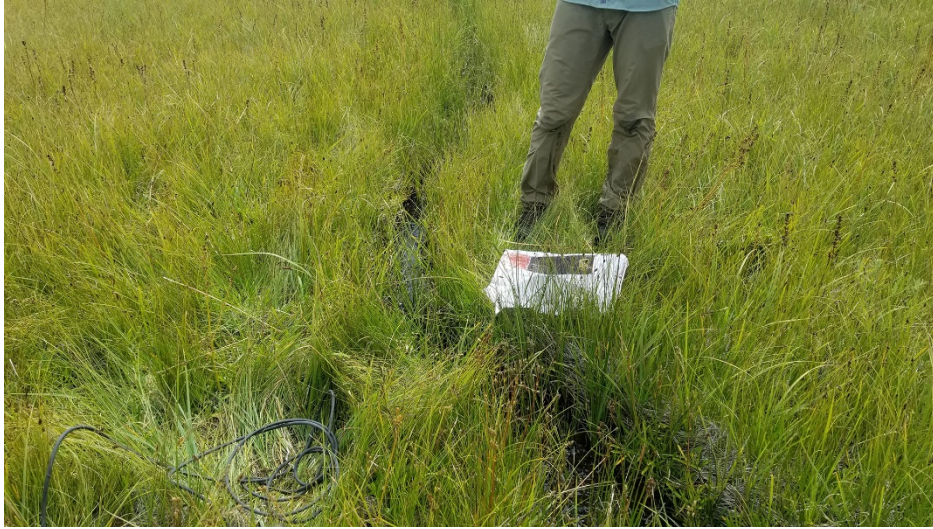
Water Quality: Location 1: in an excavated hole in standing water at 10:21:00. Location 2: at a stream exiting the wetland in flowing water at 10:44:00.

Fig 1.6 Alder Creek Meadow: Water quality measurement 2
