Assessment Data and Results for Kyburz Flat

This document includes the results and data collected from all of the protocols completed at Kyburz Flat. The first two pages are a map of Kyburz Flat, showing the locations of all assessments, by protocol and then showing the standardized rating. The third page is an overview table for all protocols including the assessment output, our standardized rating, and the factors identified that went into the rating. The following pages are the data sheets and/or summary results of each protocol.

Meadow Assessment Comparison Project – Kyburz Flat Survey Summary Report, Springs Online Site ID 250061

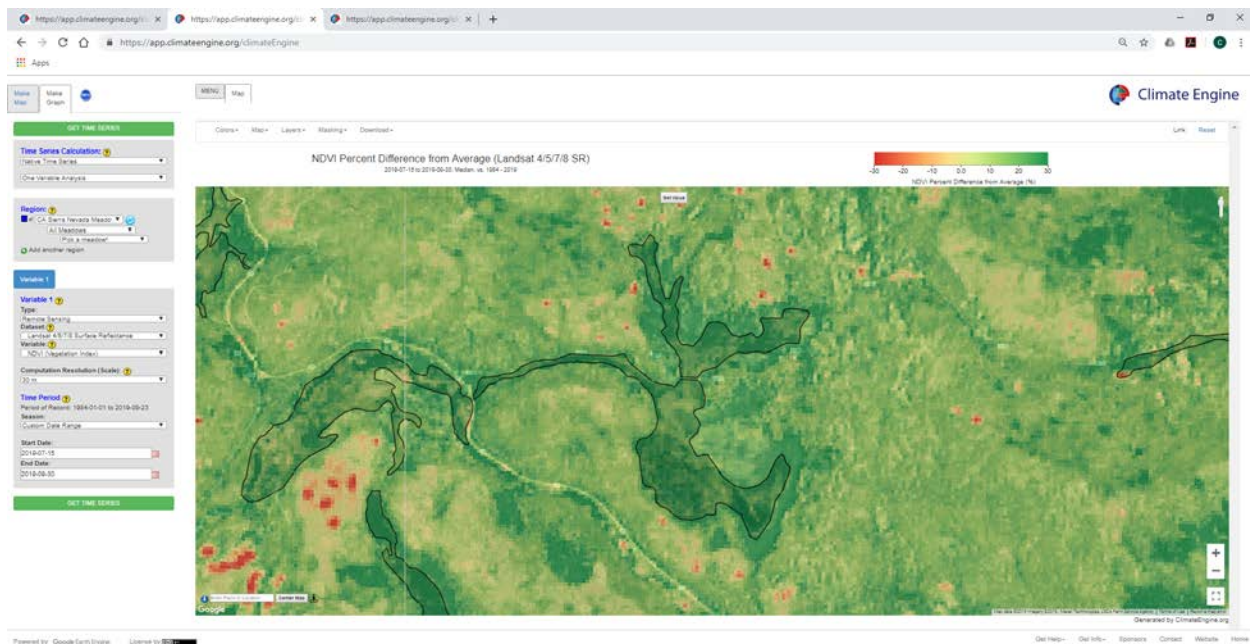
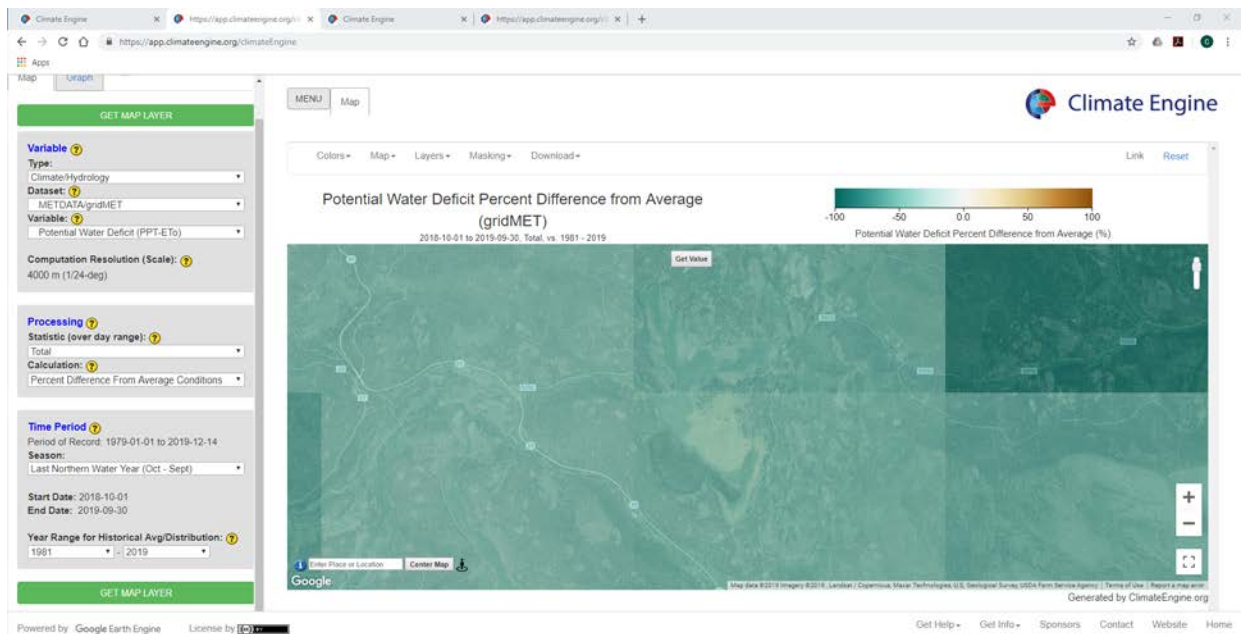
Relative to the historical (1984-2019 record), late summer (July 15-Sept 30) 2019 **NDVI is higher than average in most parts of the meadow, due to the above normal water year**. This is the expected relationship. Differences in the anomaly magnitudes potentially indicate differences in responses to climate within the meadow or potentially indicate places where drying is occurring over time (lower anomaly areas). The central portion of the meadow which contained dry meadow and upland vegetation, and where most ground assessments took place show a lower anomaly, potentially indicating drying over time.

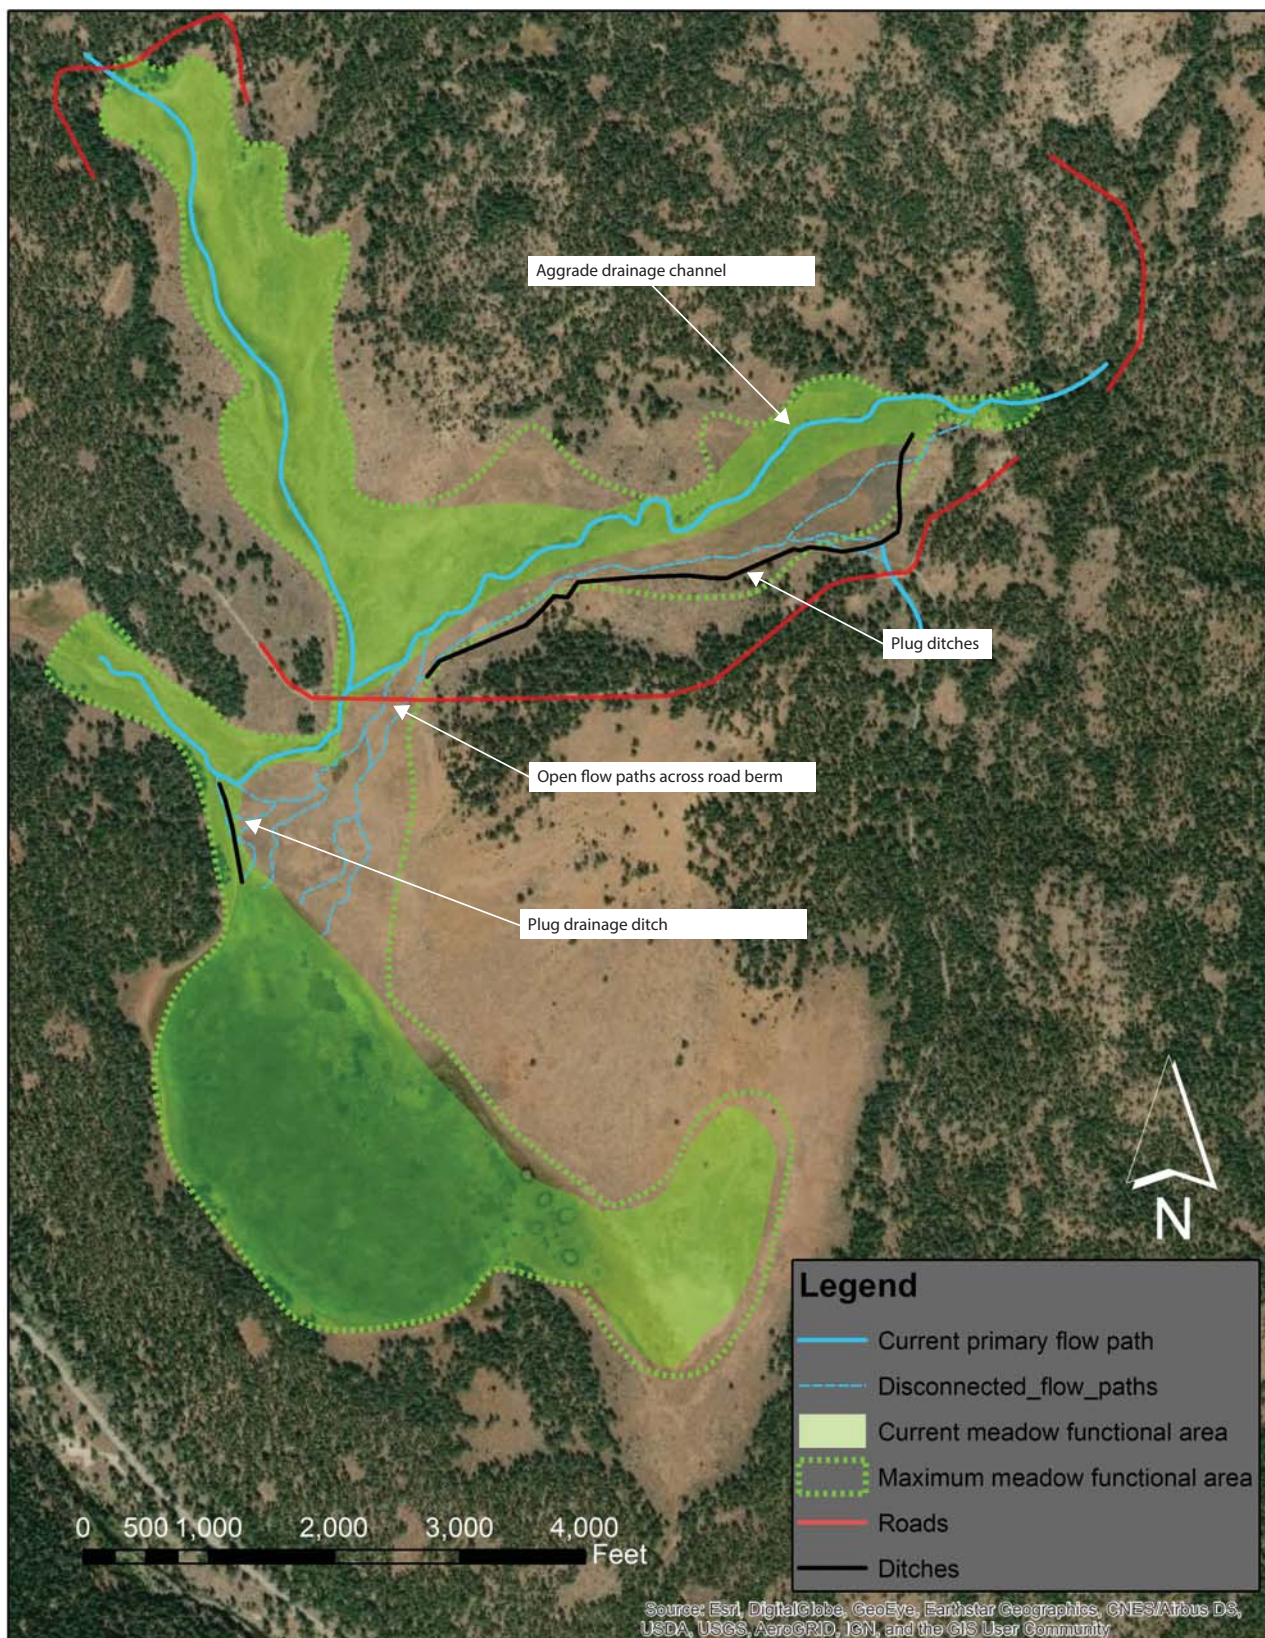
Kyburz Meadow Priority Actions

In Kyburz Flat most of the disconnectivity occurs at the Hesses road crossing and two remnant drainage ditches

- 1) Open flow paths across the road berm
- 2) Plug the outflow ditch from Kyburz Marsh
- 3) Plug smaller ditches draining the northeast flow path
- 4) Aggrade the incised channel draining the northeast flow path

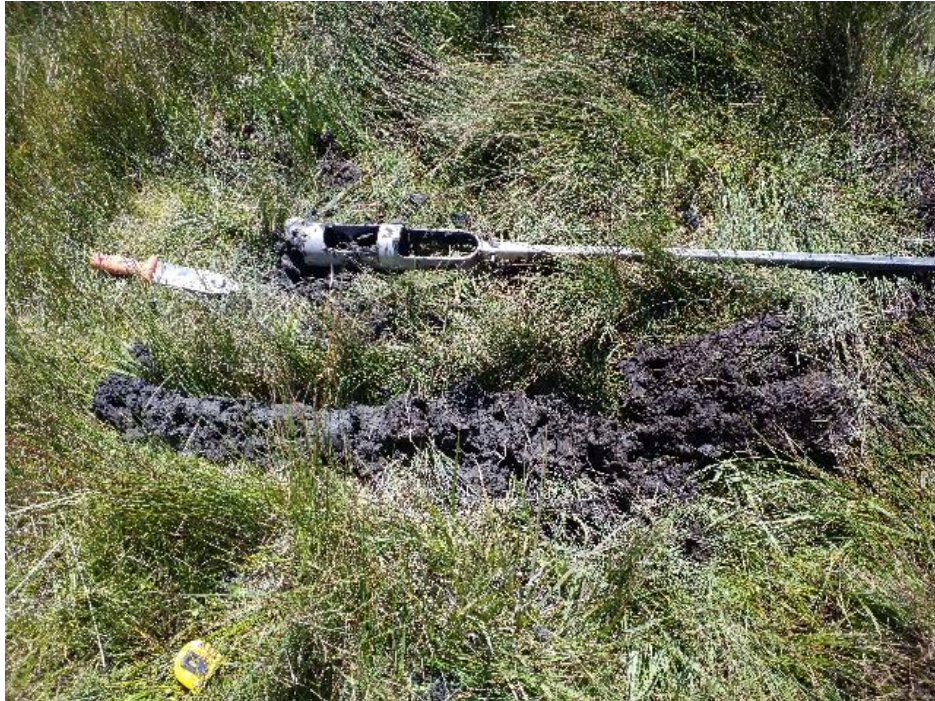
Fig 1.3 Kyburz Flat: Kyburz - Soil core location

Soil condition: At the augured hole, fibric peat was identified down to a depth of 30 cm where there was a transition to sandy clay mineral soil. While a histosol was not identified at the site it did exhibit fen characteristics including the histic epipedon described earlier, groundwater influenced and high water table.

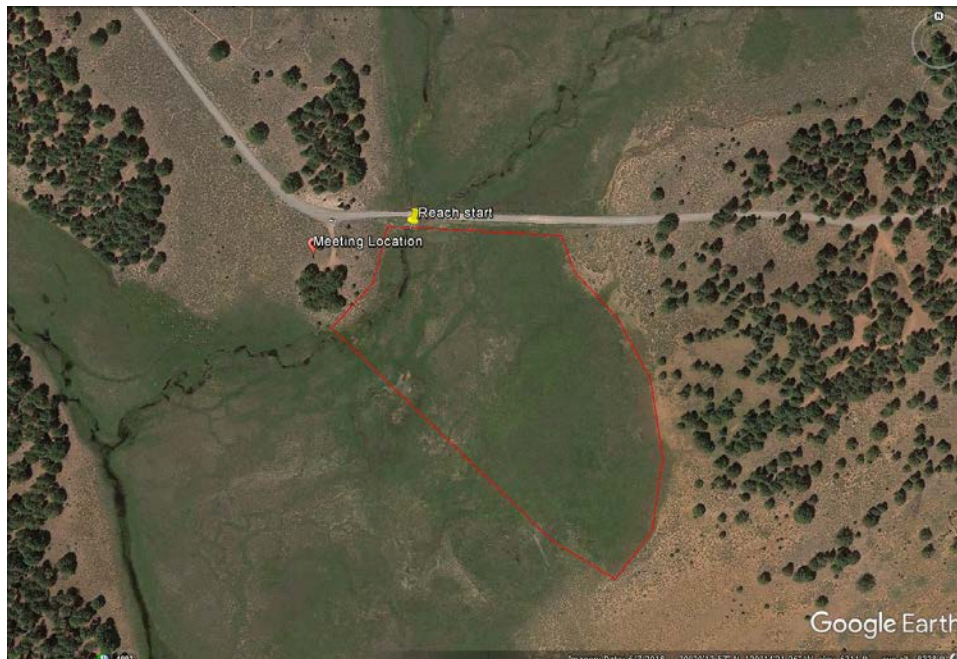
Reach starts at culvert (yellow pin below, 39°30'15.12"N, 120°14'23.68"W), going **downstream**. For lotic PFC assessment, the reach below the road was extended to the confluence with the tributary coming in from the northwest about 1000 feet below the road.

- f. **Issue identification and management recommendations** – While this road and reservoir are impactful in their current form and management, these impacts could be mitigated. The road could be hardened at the elevation of the floodplain meadow and the impacts of the water level fluctuation on the meadow could be limited through the use of headcut revetments that keep the risk of base level lowering from causing further headward migration of the incisions. While the road revision would be expensive and may not be necessary, the headcut revetments would be less expensive and more clearly important to the maintenance of riparian functions and values. However, these assessments without the broader context of other riparian PFC and values assessments are not adequate for prioritizing riparian areas and riparian restoration or management projects. PFC assessment is the first step in integrated riparian management because it identifies the level of risk and the cause of risk across multiple riparian areas or reaches for broad consideration, along
