Assessment Data and Results for Alder Creek

This document includes the results and data collected from all of the protocols completed at Alder Creek. The first two pages are a map of Alder Creek, showing the locations of all assessments, by protocol and then showing the standardized rating. The third page is an overview table for all protocols including the assessment output, our standardized rating, and the factors identified that went into the rating. The following pages are the data sheets and/or summary results of each protocol.

GDE Level I Inventory Assessment Summary: Alder Creek Meadow

Alder Creek Meadow - Meadow Assessment Comparison Project Survey Summary Report, Springs Online Site ID 250064

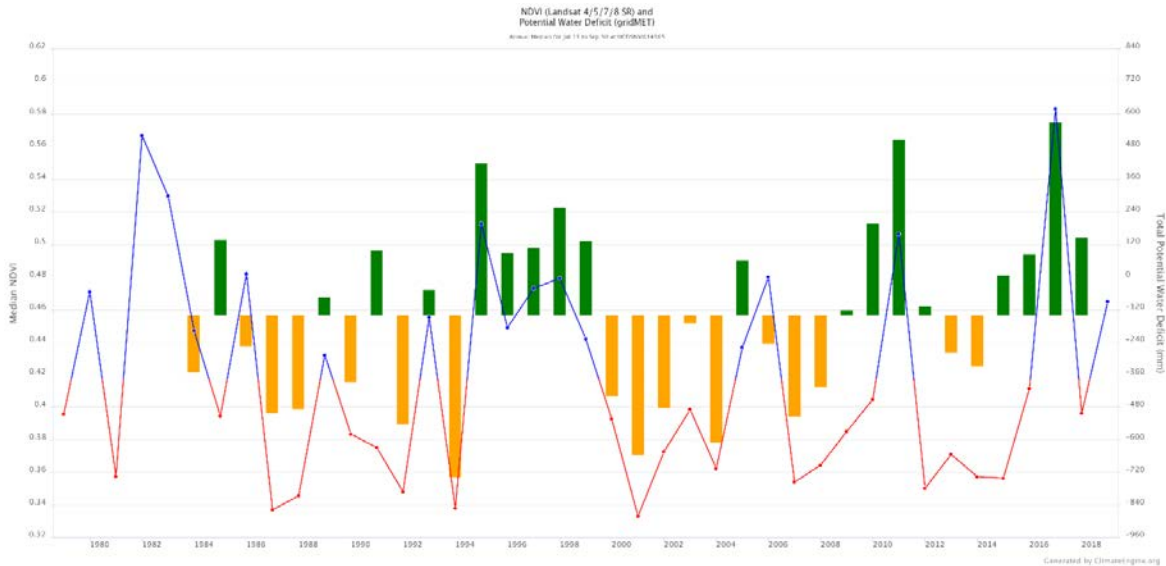
Over time, potential water deficit (PPT-PET) and NDVI tend to correspond well with each other. **No apparent changes in their relationship over time that would indicate disturbance or changes due to management.**

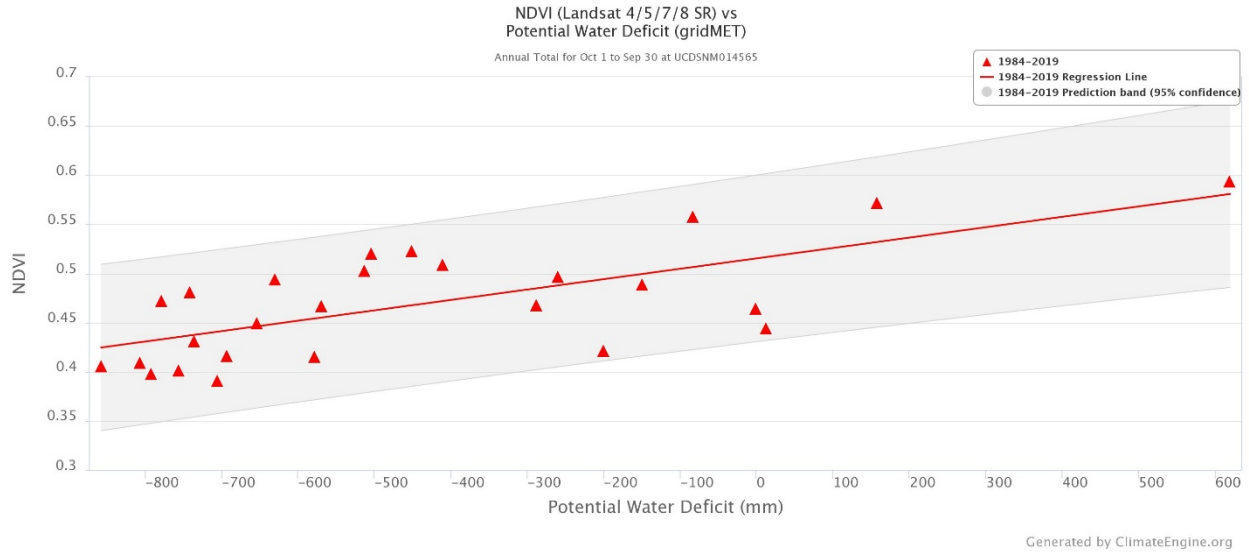
NDVI is somewhat sensitive to potential water deficit (PPT-PET), with NDVI values varying from about 0.42 to 0.59, on average, between the highest and lowest water deficit years. This suggests that water year climate is likely to influence conditions in this meadow and should be considered when making comparisons of ground assessments among years. Because this is a large meadow comprised of many different hydrogeomorphic surfaces, it is likely that drier parts of the meadow are driving this sensitivity more so than areas with more consistently high water availability.

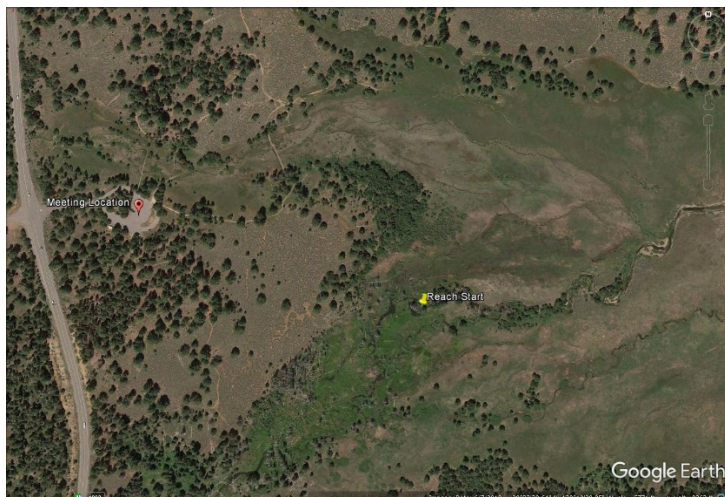
Reach starts at 39°22'28.6"N 120°10'37.3"W (yellow pin) going **downstream**. This lotic reach was extended down to the shore of Prosser Reservoir and therefore includes some area outside of this photo. In addition, the north lobe of the meadow was assessed with lentic PFC. The lentic area was assumed to be from Highway 89 (where a culvert comes under the highway from a spring west of the highway) down to the reservoir or to the stream (lotic reach) that flow into the reservoir. While the meadows converge, the zone of assessment for the lentic riparian meadow was the area influenced primarily by water from the north branch. That includes a fen dependent also on water upwelling to the east of the boardwalk trail that can be observed crossing the meadow east northeast of the meeting location.
