Assessment Data and Results for Kyburz Flat

This document includes the results and data collected from all of the protocols completed at Kyburz Flat. The first two pages are a map of Kyburz Flat, showing the locations of all assessments, by protocol and then showing the standardized rating. The third page is an overview table for all protocols including the assessment output, our standardized rating, and the factors identified that went into the rating. The following pages are the data sheets and/or summary results of each protocol.

Meadow Assessment Comparison Project – Kyburz Flat Survey Summary Report, Springs Online Site ID 250061

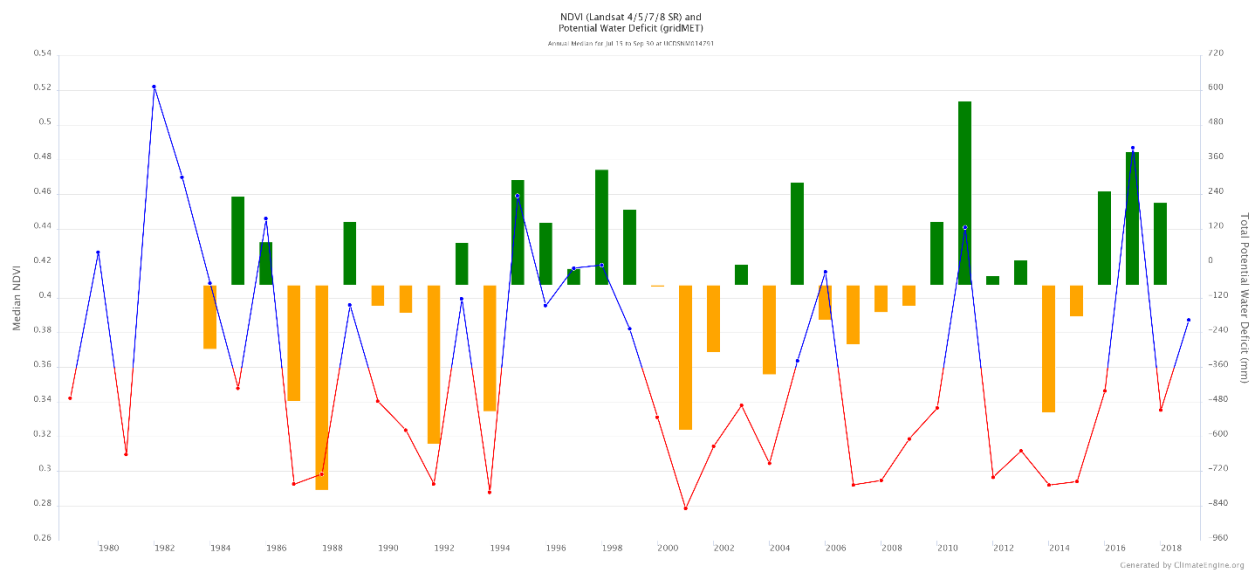
Climate Sensitivity Assessment (based on spatial averages of entire lower meadow polygon):

Over time, potential water deficit (PPT-PET) and NDVI tend to correspond well with each other. ***No apparent changes in their relationship over time that would indicate disturbance or changes due to management.***

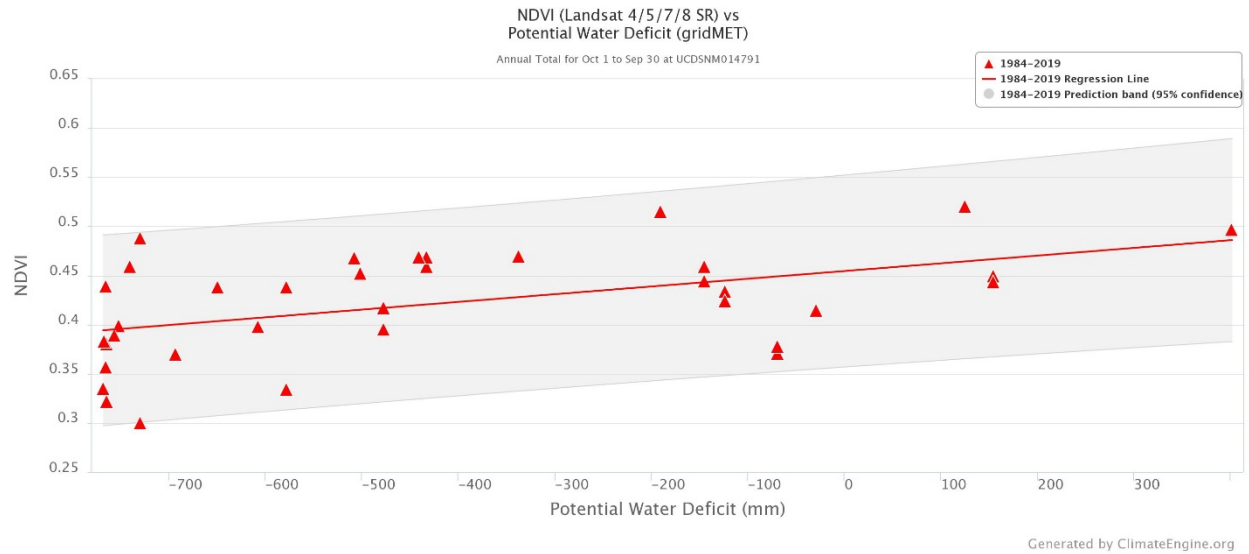
NDVI is somewhat sensitive to potential water deficit (PPT-PET), with NDVI values varying from about 0.39 to 0.5, on average, between the highest and lowest water deficit years. This sensitivity is relatively low compared to other meadows. It represents an average across very wet and very dry parts of the meadow and thus does not capture the variation in sensitivities that likely exist. Water year climate is likely to influence conditions in dry parts of this meadow and should be considered when making comparisons of ground assessments among years.

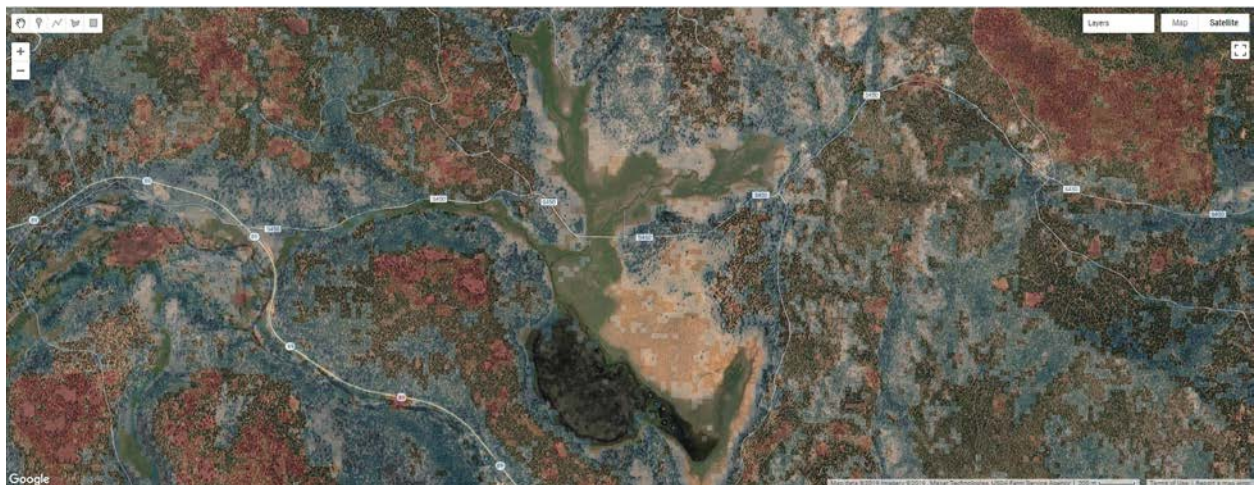
Trend Assessment (note that this capability is coming soon to Climate Engine but is not yet available):

1984-2018 trend in median July-Sept NDVI (red=declining NDVI, blue=increasing NDVI, no color= trend not significant): ***Most area within the meadow shows no trend. Increasing trends around periphery of meadow could be due to conifer encroachment.*** The lack of trend in the rest of the meadow does not necessarily indicate static conditions, rather it indicates a lack of consistent upward or downward trending over the 1984-2019 time period that was analyzed. The area surrounding the meadow shows much variation in upward and downward trends due to fire and forest thinning. Changes in forest water use associated with these changes has the potential to affect water availability in the meadow.
