**CARMAN WATERSHED RESTORATION PROJECT PHASE 2  
POST-PROJECT and ADAPTIVE MANAGEMENT  
MONITORING REPORT**

**SITES 1, 2, 4, AND 8**

**(California Department of Fish and Wildlife Watershed Restoration  
Grant Program Agreement #P1796015)**

**March 2020**

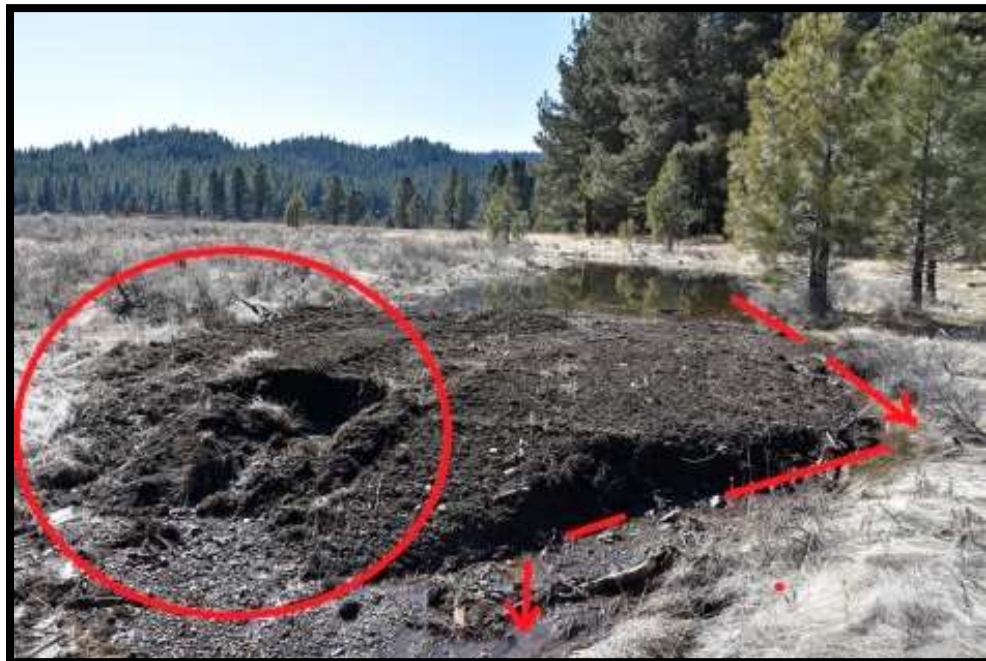
Bottom fill areas of Site #1 Folchi Meadows and Carman Creek are exhibiting some minor settling and erosion. Adaptive management measures to stabilize these areas are included in this report and will be implemented by the TNF during 2020 to ensure proper long-term function and restoration success.

**Carman Creek East Fill Feature Minor Erosion (View W)**

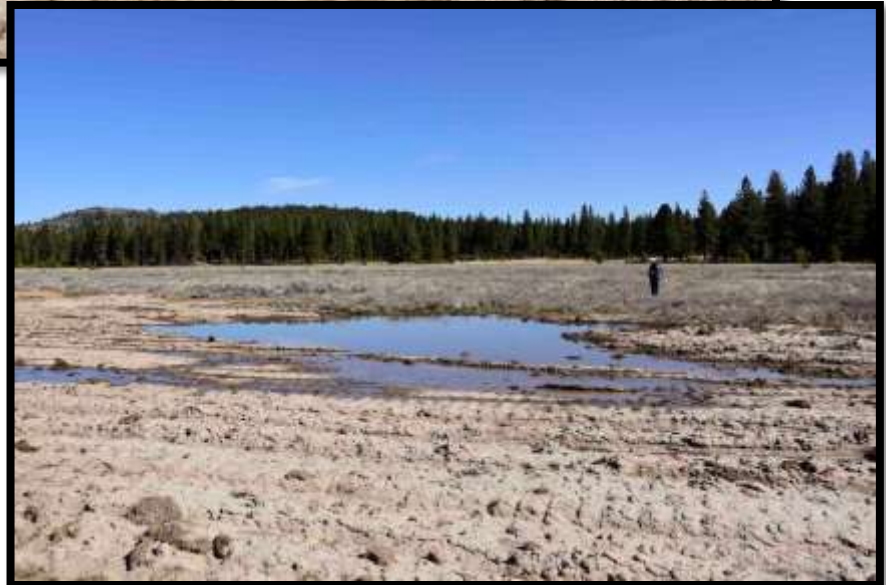
**Overland Flow From  
Existing Peat Bog Spring  
Spreading Across Filled  
Gully and Meadow  
Floodplain From West to  
East March 2020 (View N)**

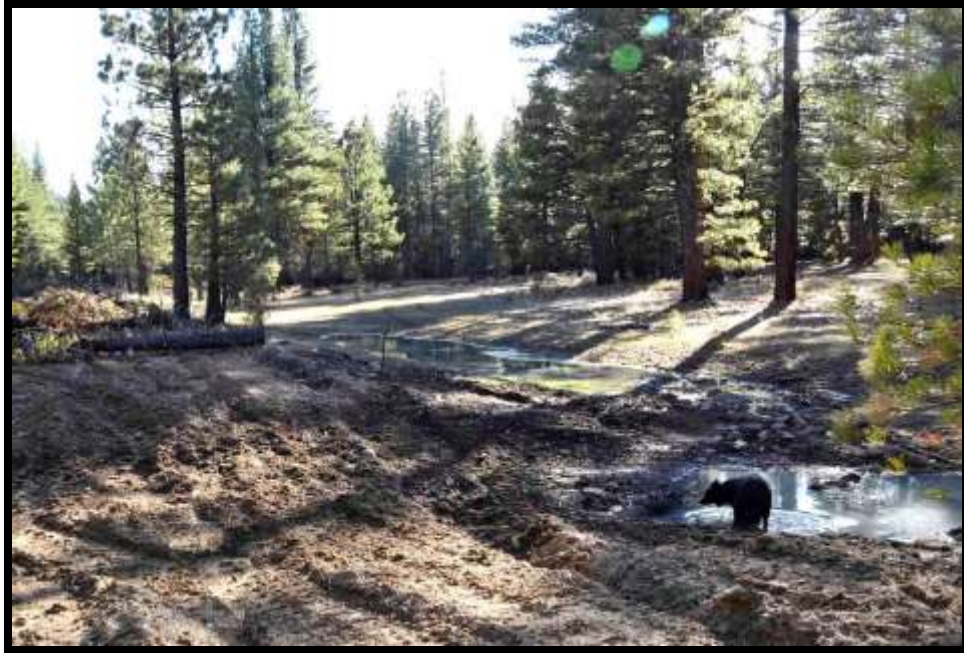
**Restored Railroad Grade Water Feature Supporting Sticky Pyrrocoma Habitat  
February 2020 (View SW)**

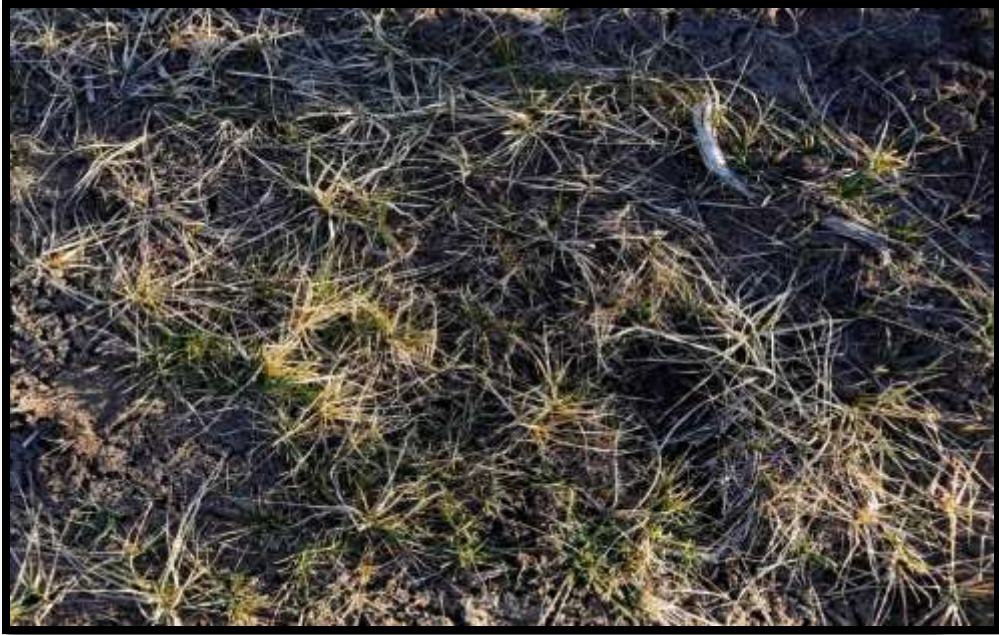
Qualitative visual observation of early season salvaged wetland vegetation placed on the filled gully indicates significant “greening up” of transplanted vegetation mats is occurring. It is anticipated that vegetation cover response on the filled gully will be excellent during the first growing season. Plant community species composition will trend towards a prevalence of desirable meadow, wetland, and riparian plant species over the next two to three growing seasons with excellent vegetation response anticipated in the long-term.

**Transect #1 Transplanted Salvaged Vegetation Greening Up on Filled Gully Area**

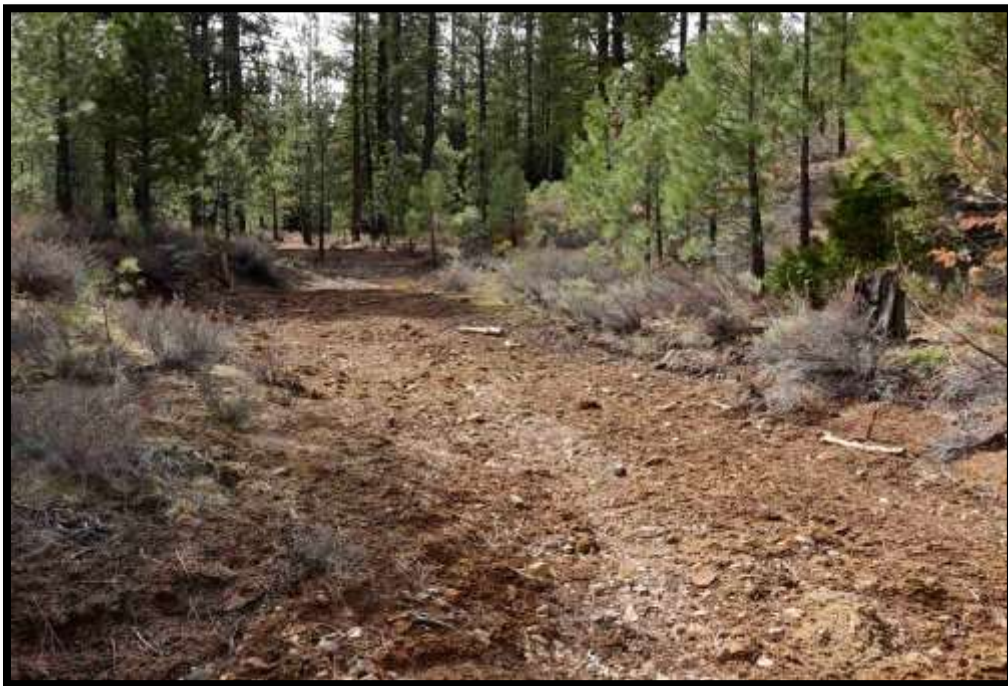
Surface water was not observed at Site #8 during early season monitoring (February-March 2020); however, a small seep in the north project area was releasing water onto the filled gully with no erosion observed.

**Photo Monitoring Station #6 Above Seep March 2020 (View S)**

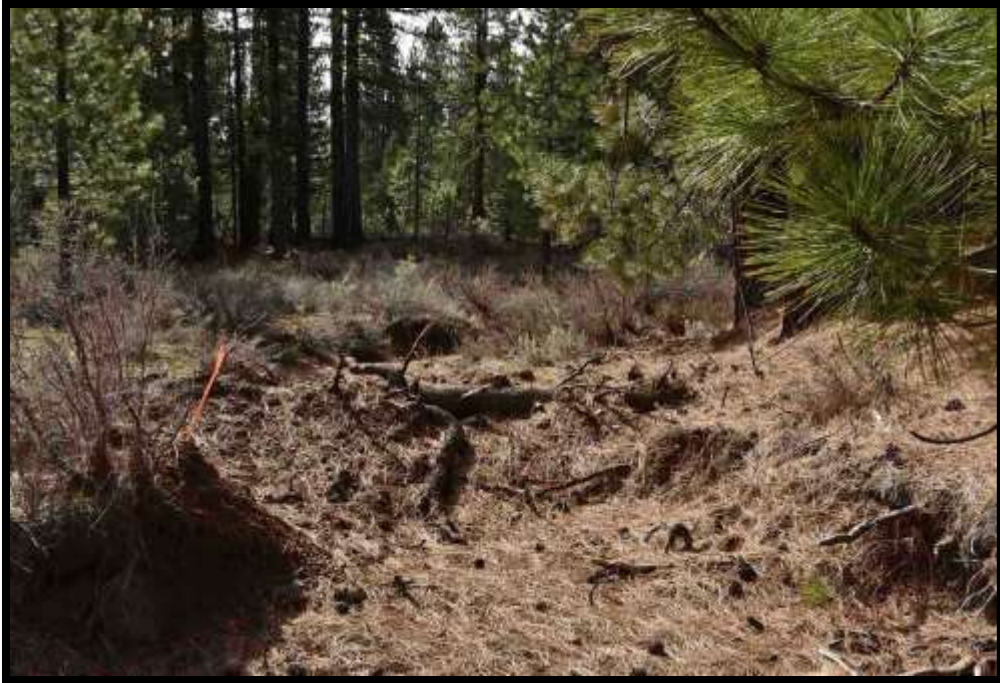
**Log Grade Control #1 in Meadow Gully South of North Meadow March 2020 (View S)**

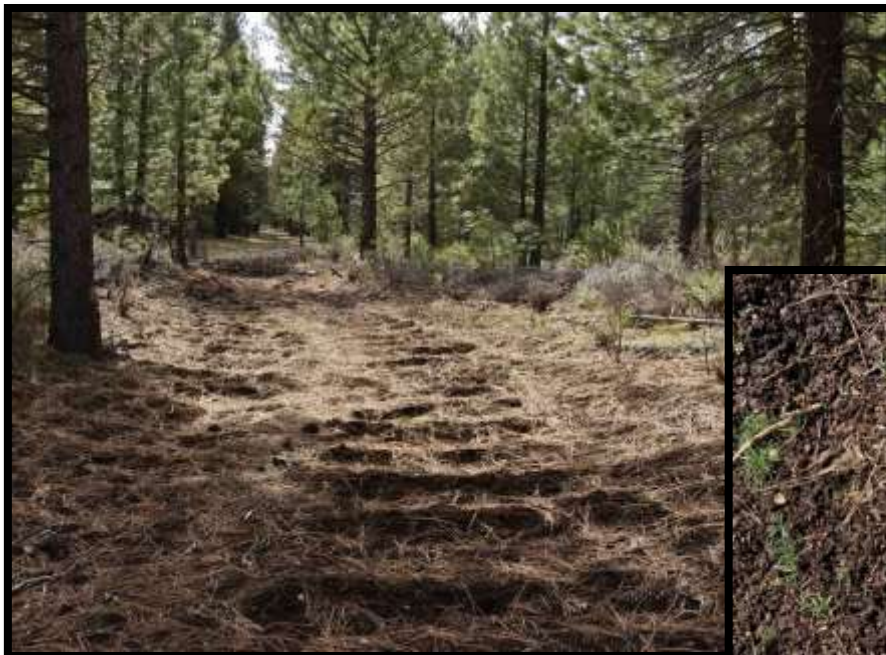
Qualitative visual observation of early season vegetation indicates significant grass seedling establishment is occurring on rehabilitated access areas where topsoil and forest duff was spread over disturbed areas.

**Access Road  
Rehabilitation and  
Natural Revegetation  
March 2020**

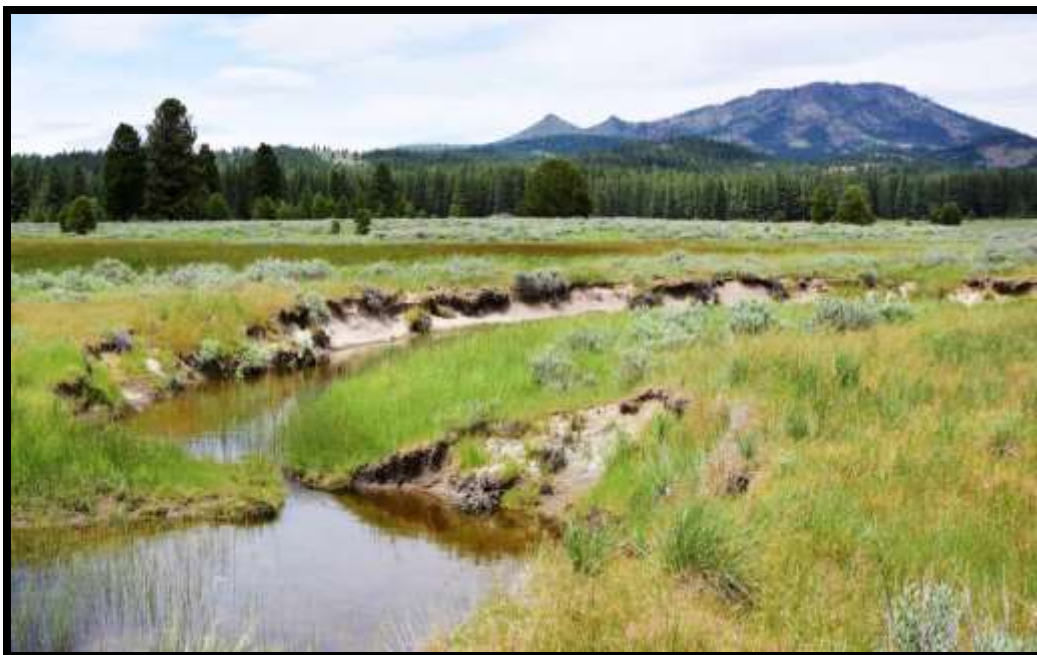
**Gully Erosion Threatening to Cut Into Existing Peat Bog Spring June 2018 (View NW)**

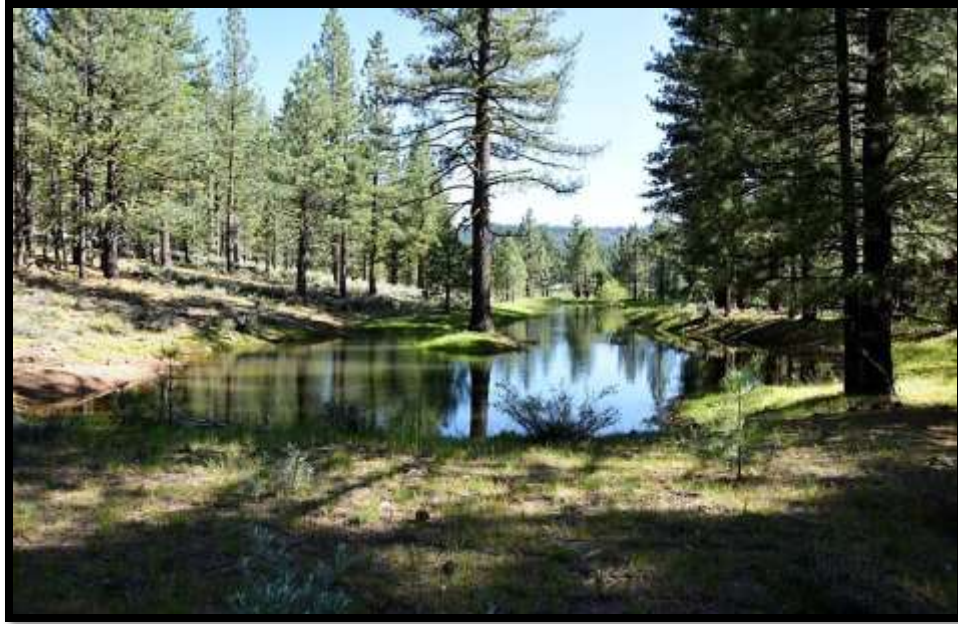
**Railroad Grade Excavated Ditch  
Spring Ponding  
May 2018 (View N)**

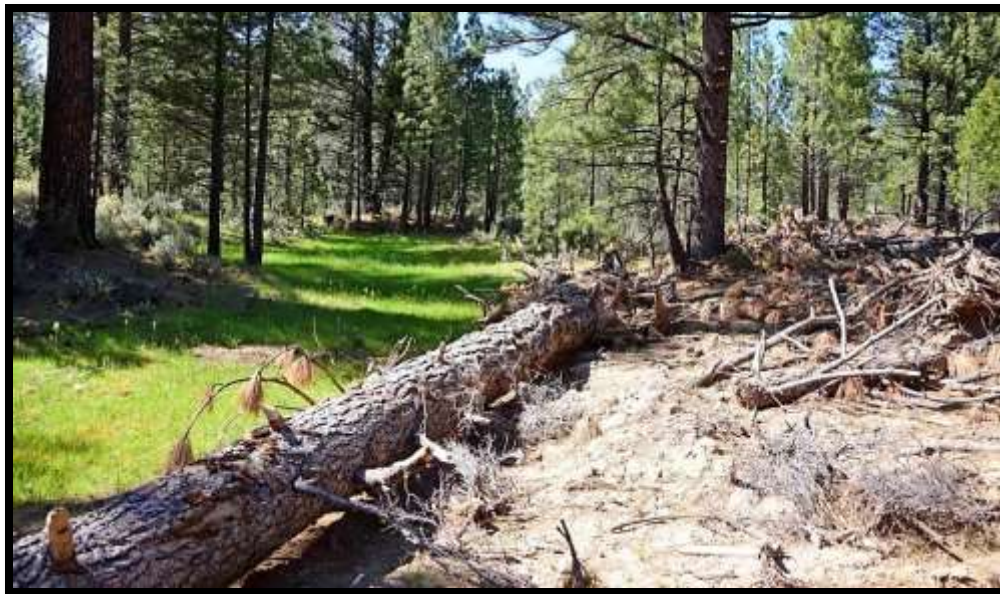
**Railroad Grade and Excavated Ditch Transitional Meadow  
May 2018 (View N)**

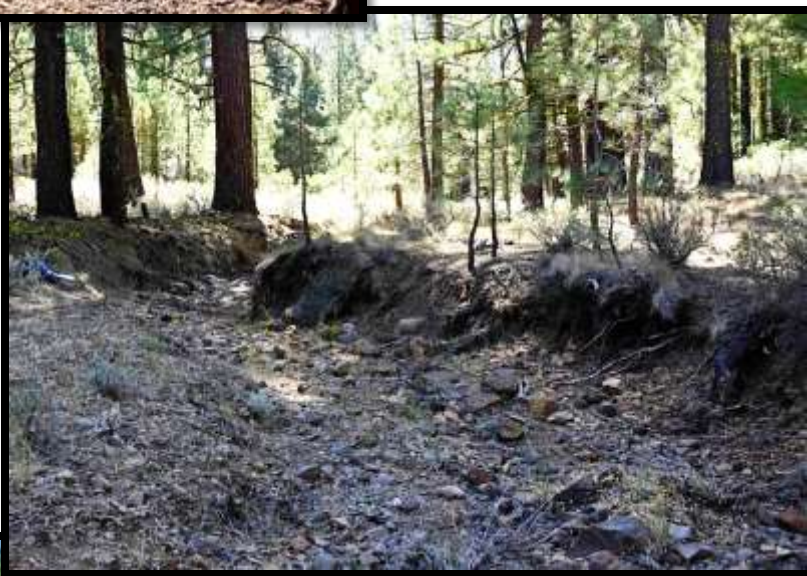
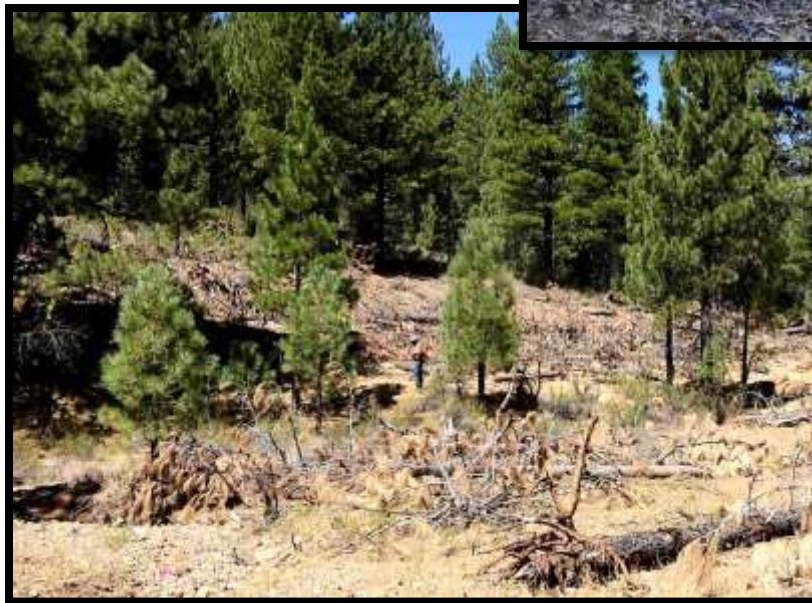
**North Project Area West Gully  
Erosion (Typical)  
(View S)**
